General Information

Make	Toyota	Model	Hilux
YOM	2025	Odo Meter Reading	25,806
Registration No.	DBQ5050	Chassis No.	MR0AB8DD9R5038788
CC	2.4	Transmission	A/T
Fuel Type	Diesel	Type of Body	Pickup
Colour	Black

Body / Panel Condition

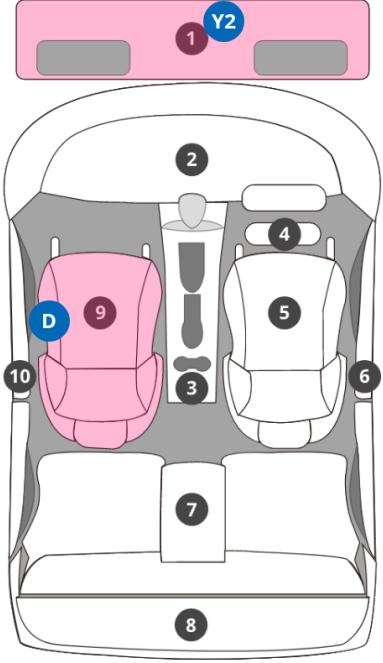
Interior Evaluation : B	Exterior Evaluation : C

<p>a : Cut, Fray d : Loose, Deformed k : Animal Hair s : Smell t : Cigarette Burns x : Defective y : Stain</p>

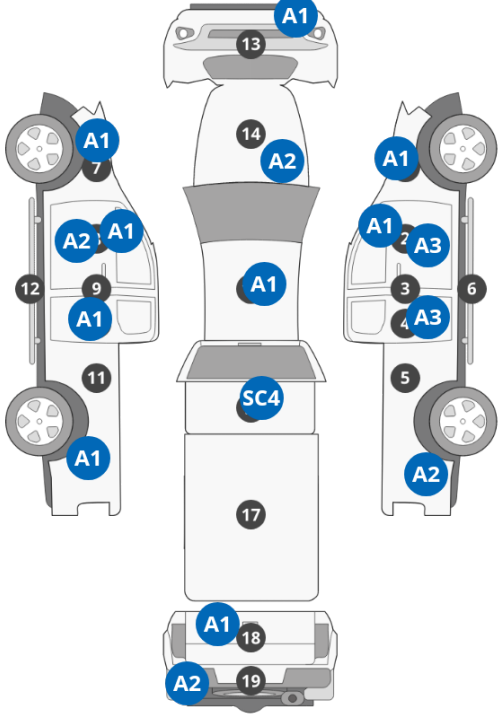
<p>A : Scratch AU : Scratch & Dent B : Modified C : Corrosion G : Stone chip P : Faded S : Rust SC : Rust & Corrosion U : Dent X : Defective Y : Crack, Gap</p>
Remarks (L) Front Seat - Worn - Yes / Ceiling - Grime - Small	Remarks (R) Front Fender, Molding - Scratch - Minimal / (R) Mirror - Scratch - Minimal / (R) Front Door, Molding - Scratch - Medium / (R) Rear Door, Molding - Scratch - Medium / (R) Side Gate - Scratch - Small / Rear Bumper, Lamps, Panels - Scratch - Small / Rear Gate - Scratch - Minimal / (L) Side Gate - Scratch - Minimal / (L) Mirror - Scratch - Minimal / (L) Rear Door, Molding - Scratch - Minimal / (L) Front Door, Molding - Scratch - Small / (L) Front Fender, Molding - Scratch - Minimal / Front Bumper, Grille, Lamps - Scratch - Minimal / Bonnet, Headlight - Scratch - Small / Roof - Scratch - Minimal / Cab Back Panel - Rust, Corrosion - Large

Inspector Notes
with warranty booklet, jack and tools, with spare tire and LTO PLATE, scratched and cracked tail light
