General Information

Make	Toyota	Model	Hilux Tamaraw
YOM	2025	Odo Meter Reading	49,113
Registration No.	NKO8849	Chassis No.	PAHACACA8S6423677
CC	2.4	Transmission	M/T
Fuel Type	Diesel	Type of Body	Utility Passenger
Colour	White

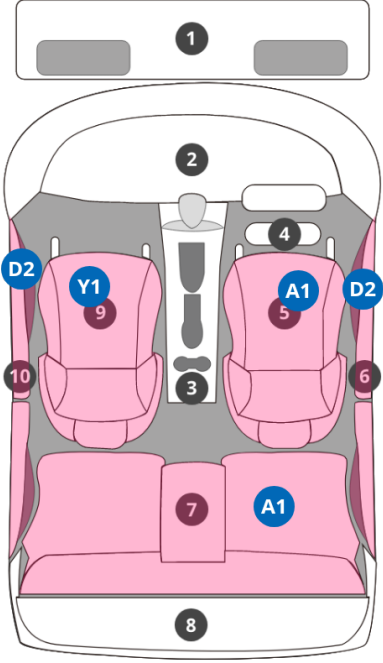
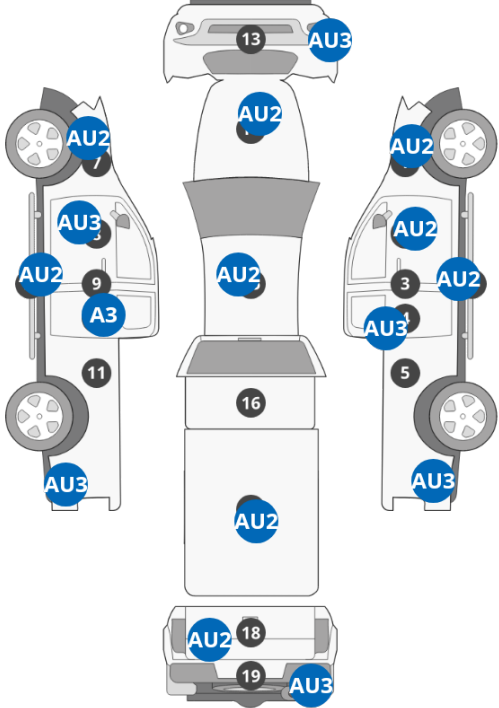
Interior Evaluation :	A	Exterior Evaluation :	E

<p>a : Cut, Fray d : Loose, Deformed k : Animal Hair s : Smell t : Cigarette Burns x : Defective y : Stain</p>		<p>A : Scratch AU : Scratch & Dent B : Modified C : Corrosion G : Stone chip P : Faded S : Rust SC : Rust & Corrosion U : Dent X : Defective Y : Crack, Gap</p>	
<p>Remarks (L) Front Seat - Grime - Minimal / (R) Front Seat - Cut, Crack - Minimal / (L) Front Trim - Worked - Small / (R) Front Trim - Worked - Small / Rear Seat - Cut, Crack - Minimal</p>		<p>Remarks (L) Rear Door, Molding - Scratch - Medium / (L) Front Fender, Molding - Scratch & Dent - Small / (L) Front Door, Molding - Scratch & Dent - Medium / Bonnet, Headlight - Scratch & Dent - Small / (R) Front Fender, Molding - Scratch & Dent - Small / (R) Front Door, Molding - Scratch & Dent - Small / Roof - Scratch & Dent - Small / (R) Rear Door, Molding - Scratch & Dent - Medium / (R) Side Gate - Scratch & Dent - Medium / Rear Gate - Scratch & Dent - Small / Rear Bumper, Lamps, Panels - Scratch & Dent - Medium / Cargo Bed Floor - Scratch & Dent - Small / (L) Side Gate - Scratch & Dent - Medium / (L) Step, In-panel, Side Spoiler - Scratch & Dent - Small / (R) Step, In-panel, Side Spoiler - Scratch & Dent - Small / Front Bumper, Grille, Lamps - Scratch & Dent - Medium</p>

Inspector Notes
with LTO plate, with spare tire, with jack, with manual and warranty booklet, with spare key, no reverse camera, no tools, scratches on taillight and headlight, issue in headunit.
