General Information

Make	Toyota	Model	Vios
YOM	2025	Odo Meter Reading	21,903
Registration No.	NKH2665	Chassis No.	PA1B18F36R4271158
CC	1.3	Transmission	CVT
Fuel Type	Gas	Type of Body	Sedan
Colour	Red

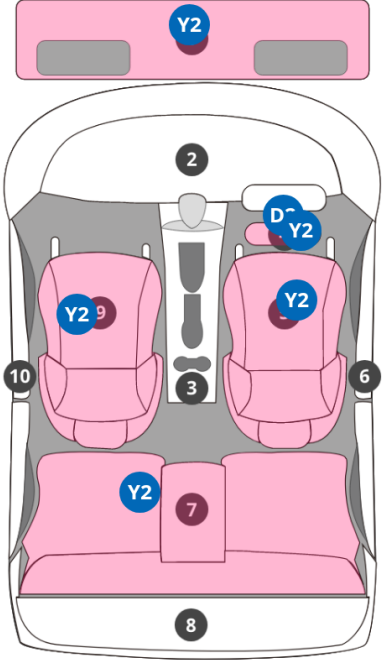
Interior Evaluation : B	Exterior Evaluation : E

<p>a : Cut, Fray d : Loose, Deformed k : Animal Hair s : Smell t : Cigarette Burns x : Defective y : Stain</p>

<p>A : Scratch AU : Scratch & Dent B : Modified C : Corrosion G : Stone chip P : Faded S : Rust SC : Rust & Corrosion U : Dent X : Defective Y : Crack, Gap</p>
<p>Remarks (L) Front Floor Mat - Worked - Small / (R) Front Floor Mat - Grime - Small / (R) Front Seat - Grime - Small / (L) Front Seat - Grime - Small / Rear Seat - Grime - Small / Ceiling - Grime - Small</p>	<p>Remarks Roof - Scratch - Small / (L) Front Fender, Molding - Scratch - Medium / Bonnet, Headlight - Scratch - Medium / (R) Front Fender, Molding - Scratch - Medium / (R) Front Door, Molding - Scratch & Dent - Small / (R) Step, In-panel, Side Spoiler - Scratch & Dent - Medium / (R) Rear Door, Molding - Scratch & Dent - Small / (R) Rear Fender, Molding - Scratch & Dent - Small / Trunk Hood, Rear Gate - Scratch & Dent - Minimal / Rear Bumper, Lamps, Panels - Scratch - Large / (L) Rear Fender, Molding - Scratch & Dent - Small / (L) Rear Door, Molding - Scratch & Dent - Large / (L) Front Door, Molding - Scratch & Dent - Small / (L) Step, In-panel, Side Spoiler - Scratch & Dent - Small / Front Bumper, Grille, Lamps - Scratch - Medium</p>

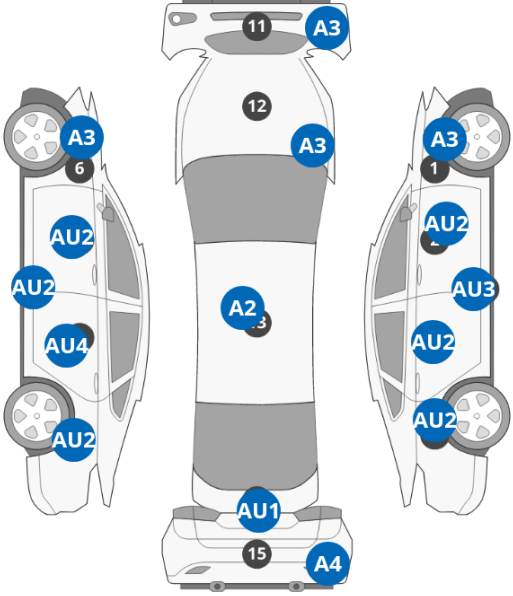
<p>Inspector Notes</p>
<p>with LTO plate, with spare tire, with spare key, with jack, with manual and warranty booklet, with reverse camera, scratches on taillight and headlight.</p>
