General Information

Make	Toyota	Model	Vios
YOM	2025	Odo Meter Reading	81,293
Registration No.	NKG8748	Chassis No.	PA1B18F31R4278826
CC	1.3	Transmission	CVT
Fuel Type	Gas	Type of Body	Sedan
Colour	Black

Body / Panel Condition

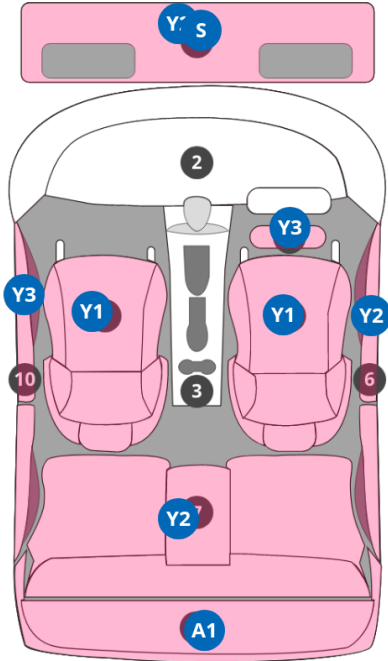
Interior Evaluation : B	Exterior Evaluation : D

<p>a : Cut, Fray d : Loose, Deformed k : Animal Hair s : Smell t : Cigarette Burns x : Defective y : Stain</p>

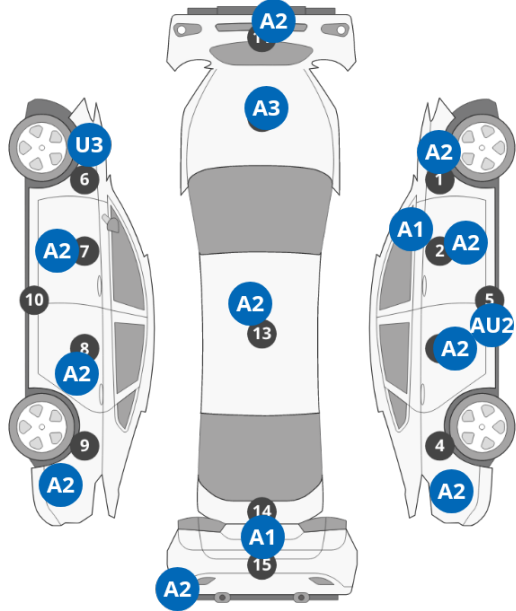
<p>A : Scratch AU : Scratch & Dent B : Modified C : Corrosion G : Stone chip P : Faded S : Rust SC : Rust & Corrosion U : Dent X : Defective Y : Crack, Gap</p>
<p>Remarks (R) Front Seat - Grime - Minimal / (R) Front Trim - Grime - Small / Rear Seat - Grime - Small / Trunk Room - Worn, Scratch, Cut, Crack - Minimal / (L) Front Trim - Grime - Medium / (L) Front Seat - Grime - Minimal / (L) Front Floor Mat - Grime - Medium / Ceiling - Grime - Small / Overall Interior - Smell - Yes</p>	<p>Remarks (L) Front Fender, Molding - Dent - Medium / Bonnet, Headlight - Scratch - Medium / Front Bumper, Grille, Lamps - Scratch - Small / (R) Front Fender, Molding - Scratch - Small / (R) Mirror - Scratch - Minimal / (R) Front Door, Molding - Scratch - Small / (R) Step, In-panel, Side Spoiler - Scratch & Dent - Small / (R) Rear Door, Molding - Scratch - Small / (R) Rear Fender, Molding - Scratch - Small / Trunk Hood, Rear Gate - Scratch - Minimal / Rear Bumper, Lamps, Panels - Scratch - Small / (L) Rear Fender, Molding - Scratch - Small / (L) Rear Door, Molding - Scratch - Small / (L) Front Door, Molding - Scratch - Small / Roof - Scratch - Small</p>
