## General Information

| <b>Make</b> | Toyota | <b>Model</b> | Vios |

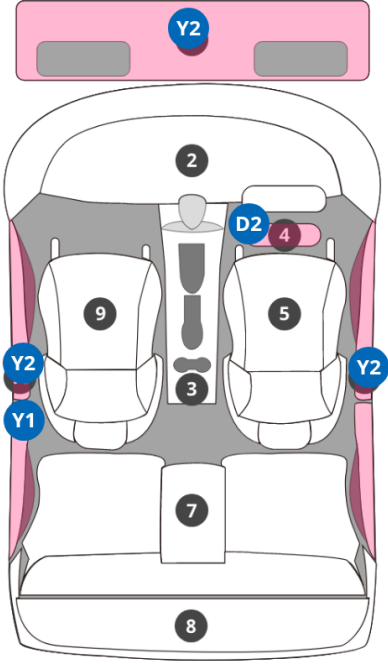
| <b>Interior Evaluation :</b> <span style="float: right; color: red; font-weight: bold;">B</span> | <b>Exterior Evaluation :</b> <span style="float: right; color: red; font-weight: bold;">E</span> |

| <p><b>Remarks</b><br/>(L) Front Trim - Grime - Small / Ceiling - Grime - Small / (L) Front Floor Mat - Worked - Small / (L) Rear Trim - Grime - Minimal / (R) Front Trim - Grime - Small</p> | <p><b>Remarks</b><br/>(L) Front Fender, Molding - Scratch &amp; Dent - Medium / Bonnet, Headlight - Scratch - Large / Front Bumper, Grille, Lamps - Scratch &amp; Dent - Large / (L) Mirror - Scratch - Minimal / (L) Rear Door, Molding - Scratch - Small / (L) Front Door, Molding - Scratch - Small / (L) Step, In-panel, Side Spoiler - Scratch &amp; Dent - Medium / (L) Rear Fender, Molding - Scratch - Small / Trunk Hood, Rear Gate - Scratch - Small / Rear Bumper, Lamps, Panels - Scratch - Small / (R) Rear Fender, Molding - Scratch - Small / (R) Rear Door, Molding - Scratch - Minimal / (R) Front Door, Molding - Scratch - Small / (R) Mirror - Scratch - Small / (R) Front Fender, Molding - Scratch - Small / Roof - Scratch - Small</p> |
