General Information

Make	Toyota	Model	Vios
YOM	2025	Odo Meter Reading	13,973
Registration No.	NKG1335	Chassis No.	PA1B18F37R4274165
CC	1.3	Transmission	CVT
Fuel Type	Gas	Type of Body	Sedan
Colour	Blue

Body / Panel Condition

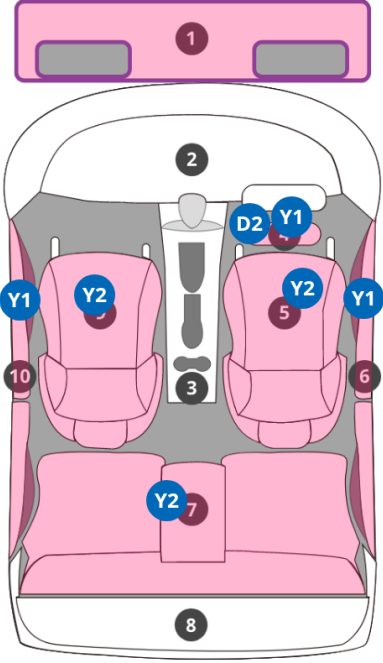
Interior Evaluation : B	Exterior Evaluation : C

<p>a : Cut, Fray d : Loose, Deformed k : Animal Hair s : Smell t : Cigarette Burns x : Defective y : Stain</p>

<p>A : Scratch AU : Scratch & Dent B : Modified C : Corrosion G : Stone chip P : Faded S : Rust SC : Rust & Corrosion U : Dent X : Defective Y : Crack, Gap</p>
<p>Remarks (L) Front Seat - Grime - Small / (R) Front Seat - Grime - Small / Rear Seat - Grime - Small / Room Lamp - Missing - Yes / (L) Front Trim - Grime - Minimal / (R) Front Trim - Grime - Minimal / (L) Front Floor Mat - Crinkle - Small / (R) Front Floor Mat - Grime - Minimal</p>	<p>Remarks Bonnet - Repair Traces - Yes / Roof - Scratch & Dent - Small / (L) Front Door, Molding - Scratch - Small / (L) Rear Door, Molding - Scratch - Small / (L) Rear Fender, Molding - Scratch - Small / Trunk Hood, Rear Gate - Scratch & Dent - Minimal / Rear Bumper, Lamps, Panels - Scratch - Small / (R) Rear Fender, Molding - Scratch & Dent - Medium / (R) Rear Door, Molding - Scratch & Dent - Small / (R) Front Door, Molding - Scratch & Dent - Small / (R) Front Fender, Molding - Scratch - Small / Bonnet, Headlight - Scratch - Small / Front Bumper, Grille, Lamps - Scratch & Dent - Small / (L) Front Fender, Molding - Scratch - Small / (R) Step, In-panel, Side Spoiler - Scratch & Dent - Minimal / (L) Step, In-panel, Side Spoiler - Scratch & Dent - Minimal</p>
