## General Information

<b>Make</b>	Toyota	<b>Model</b>	Vios
<b>YOM</b>	2025	<b>Odo Meter Reading</b>	9,096
<b>Registration No.</b>	GBK1344	<b>Chassis No.</b>	PA1B18F36S4287575
<b>CC</b>	1.3	<b>Transmission</b>	CVT
<b>Fuel Type</b>	Gas	<b>Type of Body</b>	Sedan
<b>Colour</b>	Red

## Body / Panel Condition

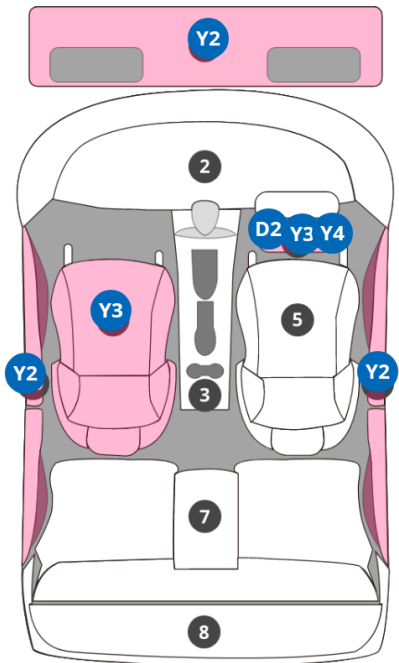
<b>Interior Evaluation :</b> <span style="float: right; color: red; font-weight: bold;">C</span>	<b>Exterior Evaluation :</b> <span style="float: right; color: red; font-weight: bold;">C</span>

<p><b>A</b> : Scratch <b>AU</b> : Scratch &amp; Dent <b>B</b> : Modified <b>C</b> : Corrosion <b>G</b> : Stone chip <b>P</b> : Faded <b>S</b> : Rust <b>SC</b> : Rust &amp; Corrosion <b>U</b> : Dent <b>X</b> : Defective <b>Y</b> : Crack, Gap</p>
<p><b>Remarks</b> (L) Front Trim - Grime - Small / (L) Front Seat - Grime - Medium / (L) Front Floor Mat - Worked - Small / Ceiling - Grime - Small / Mat Other - Grime - Medium / (R) Front Trim - Grime - Small / (R) Front Floor Mat - Grime - Large</p>	<p><b>Remarks</b> (L) Front Fender, Molding - Scratch - Small / (L) Rear Door, Molding - Scratch - Medium / (L) Rear Fender, Molding - Scratch - Small / Rear Bumper, Lamps, Panels - Scratch - Small / (R) Rear Fender, Molding - Scratch - Minimal / (R) Rear Door, Molding - Scratch - Minimal / (R) Front Door, Molding - Scratch - Small / (R) Mirror - Scratch - Minimal / Bonnet, Headlight - Scratch - Small / Front Bumper, Grille, Lamps - Scratch - Medium / Roof - Dent - Small</p>
