General Information

Make	Toyota	Model	Vios
YOM	2024	Odo Meter Reading	32,982
Registration No.	NKE1509	Chassis No.	PA1B18F3XR4257537
CC	1.3	Transmission	CVT
Fuel Type	Gas	Type of Body	Sedan
Colour	Silver

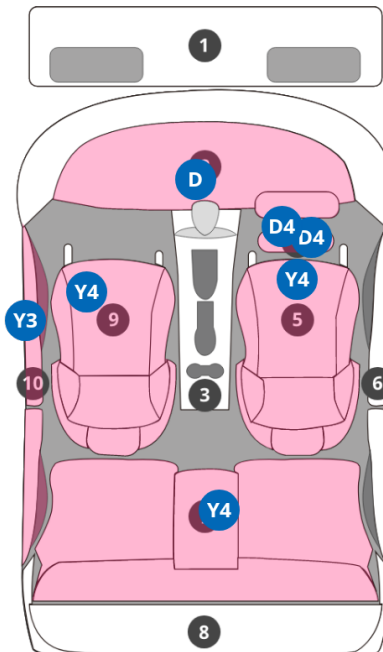
Interior Evaluation : D	Exterior Evaluation : D

<p>a : Cut, Fray d : Loose, Deformed k : Animal Hair s : Smell t : Cigarette Burns x : Defective y : Stain</p>

<p>A : Scratch AU : Scratch & Dent B : Modified C : Corrosion G : Stone chip P : Faded S : Rust SC : Rust & Corrosion U : Dent X : Defective Y : Crack, Gap</p>
<p>Remarks Rear Seat - Grime - Large / (R) Front Seat - Grime - Large / (L) Front Seat - Grime - Large / (L) Front Trim - Grime - Medium / (R) Front Floor Mat - Worked - Large / (L) Front Floor Mat - Worked - Large / Dashboard - Traces of Adhesive Tape - Yes</p>	<p>Remarks (R) Step - Repair Traces - Yes / (R) Front Fender - Repair Traces - Yes / (L) Front Fender - Repair Traces - Yes / (L) Step - Repair Traces - Yes / (R) Rear Fender - Repair Traces - Yes / (R) Rear Door - Repair Traces - Yes / (R) Step, In-panel, Side Spoiler - Scratch & Dent - Small / (R) Front Door, Molding - Scratch - Large / Trunk Hood, Rear Gate - Crack, Gap - Large / Rear Bumper, Lamps, Panels - Scratch & Dent - Large / (L) Rear Fender, Molding - Scratch - Small / (L) Rear Door, Molding - Dent - Small / (L) Front Door, Molding - Scratch - Small / (L) Front Fender, Molding - Scratch - Small / Front Bumper, Grille, Lamps - Scratch & Dent - Small / Bonnet, Headlight - Scratch - Small / (R) Front Fender, Molding - Scratch - Small / (R) Rear Door, Molding - Scratch - Small</p>
