General Information

Make	Toyota	Model	Wigo
YOM	2025	Odo Meter Reading	10,400
Registration No.	GBD8785	Chassis No.	MHKAA1BC0RJ026335
CC	1.0	Transmission	CVT
Fuel Type	Gas	Type of Body	Hatchback
Colour	Gray

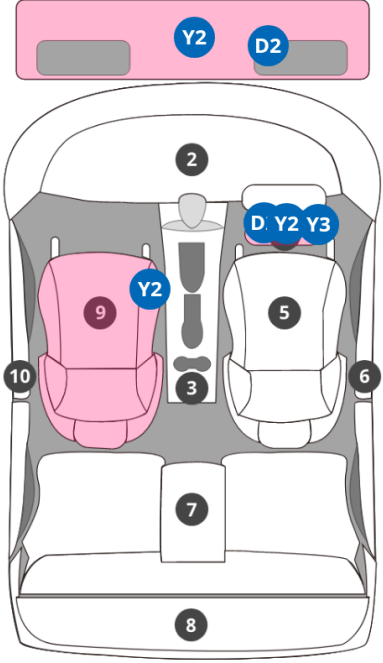
Interior Evaluation : B	Exterior Evaluation : E

<p>a : Cut, Fray d : Loose, Deformed k : Animal Hair s : Smell t : Cigarette Burns x : Defective y : Stain</p>

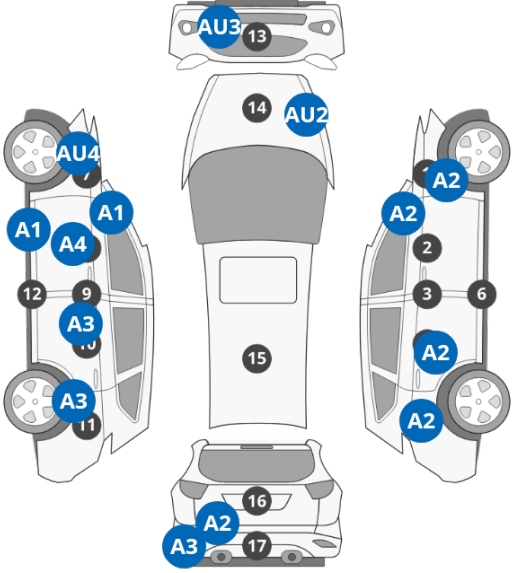
<p>A : Scratch AU : Scratch & Dent B : Modified C : Corrosion G : Stone chip P : Faded S : Rust SC : Rust & Corrosion U : Dent X : Defective Y : Crack, Gap</p>
<p>Remarks (L) Front Floor Mat - Worked - Small / (L) Front Seat - Grime - Small / Sunvisor, Sunglass Holder - Crinkle - Small / Ceiling - Grime - Small / Mat Other - Grime - Small / (R) Front Floor Mat - Grime - Medium</p>	<p>Remarks (L) Front Fender, Molding - Scratch & Dent - Large / (L) Front Door, Molding - Scratch - Large / (L) Mirror - Scratch - Minimal / (L) Rear Door, Molding - Scratch - Medium / (L) Rear Fender, Molding - Scratch - Medium / (L) Step, In-panel, Side Spoiler - Scratch - Minimal / Trunk Hood, Rear Gate - Scratch - Small / Rear Bumper, Lamps, Panels - Scratch - Medium / (R) Rear Fender, Molding - Scratch - Small / (R) Rear Door, Molding - Scratch - Small / (R) Mirror - Scratch - Small / (R) Front Fender, Molding - Scratch - Small / Bonnet, Headlight - Scratch & Dent - Small / Front Bumper, Grille, Lamps - Scratch & Dent - Medium</p>
