General Information

Make	Toyota	Model	Raize
YOM	2025	Odo Meter Reading	1,640
Registration No.	NJC5269	Chassis No.	MHKAB1BA9SJ116181
CC	1.2	Transmission	CVT
Fuel Type	Gas	Type of Body	Wagon
Colour	Silver

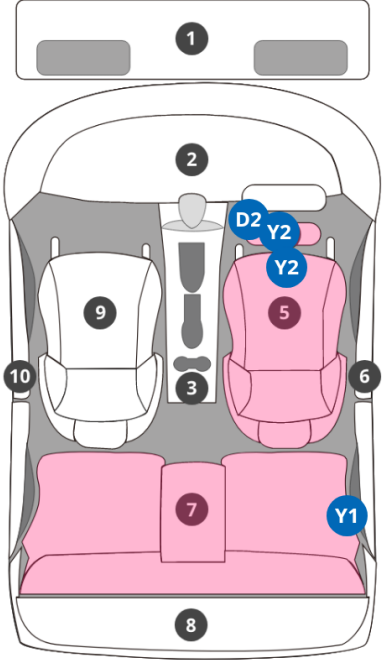
Interior Evaluation : A	Exterior Evaluation : C

<p>a : Cut, Fray d : Loose, Deformed k : Animal Hair s : Smell t : Cigarette Burns x : Defective y : Stain</p>

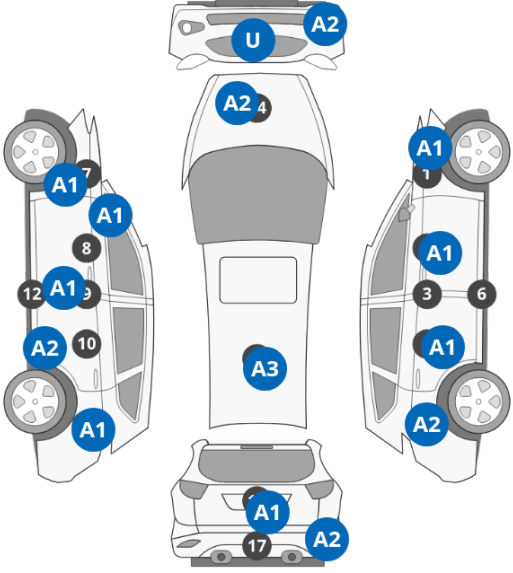
<p>A : Scratch AU : Scratch & Dent B : Modified C : Corrosion G : Stone chip P : Faded S : Rust SC : Rust & Corrosion U : Dent X : Defective Y : Crack, Gap</p>
<p>Remarks (L) Front Floor Mat - Worked - Small / Mat Other - Grime - Small / (R) Front Seat - Grime - Small / Rear Seat - Grime - Minimal</p>	<p>Remarks Member (Bolted) - Dent - Yes / (R) Front Fender, Molding - Scratch - Minimal / (R) Front Door, Molding - Scratch - Minimal / (R) Rear Door, Molding - Scratch - Minimal / (R) Rear Fender, Molding - Scratch - Small / Rear Bumper, Lamps, Panels - Scratch - Small / Trunk Hood, Rear Gate - Scratch - Minimal / (L) Rear Fender, Molding - Scratch - Minimal / (L) Mirror - Scratch - Minimal / (L) Rear Door, Molding - Scratch - Small / (L) Front Door, Molding - Scratch - Minimal / (L) Front Fender, Molding - Scratch - Minimal / Front Bumper, Grille, Lamps - Scratch - Small / Bonnet, Headlight - Scratch - Small / Roof - Scratch - Medium</p>

<p>Inspector Notes</p>
<p>with warranty booklet, jack and tools, with spare tire, with LTO plate, scratches on tail light</p>
