General Information

Make	Toyota	Model	Vios
YOM	2024	Odo Meter Reading	20,321
Registration No.	NHS3541	Chassis No.	PA1B18F33R4261221
CC	1.3	Transmission	CVT
Fuel Type	Gas	Type of Body	Sedan
Colour	Red Mica Metallic

Body / Panel Condition

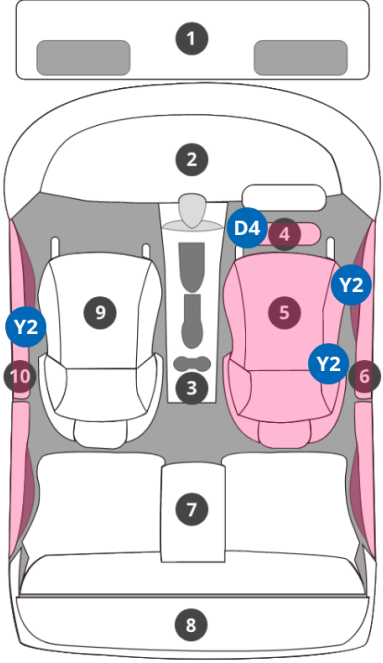
Interior Evaluation : C	Exterior Evaluation : E

<p>a : Cut, Fray d : Loose, Deformed k : Animal Hair s : Smell t : Cigarette Burns x : Defective y : Stain</p>

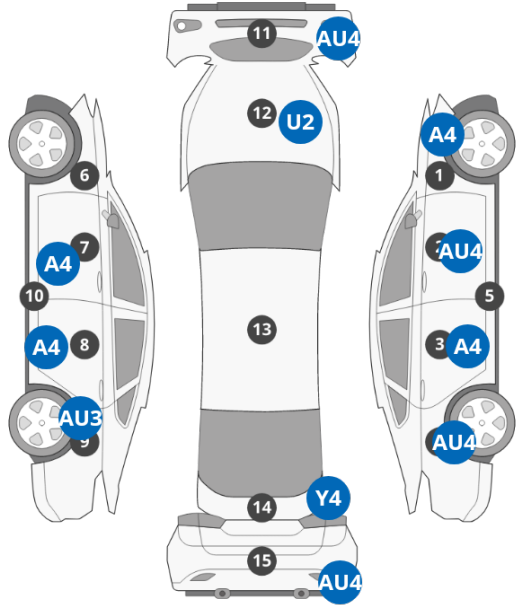
<p>A : Scratch AU : Scratch & Dent B : Modified C : Corrosion G : Stone chip P : Faded S : Rust SC : Rust & Corrosion U : Dent X : Defective Y : Crack, Gap</p>
<p>Remarks (R) Front Trim - Grime - Small / (R) Front Seat - Grime - Small / (L) Front Floor Mat - Worked - Large / (L) Front Trim - Grime - Small</p>	<p>Remarks (L) Step - Repair Traces - Yes / (L) Rear Door - Repair Traces - Yes / (L) Rear Fender - Repair Traces - Yes / (L) Front Door, Molding - Scratch - Large / (L) Rear Door, Molding - Scratch - Large / (L) Rear Fender, Molding - Scratch & Dent - Medium / Rear Bumper, Lamps, Panels - Scratch & Dent - Large / (R) Rear Fender, Molding - Scratch & Dent - Large / Trunk Hood, Rear Gate - Crack, Gap - Large / (R) Rear Door, Molding - Scratch - Large / (R) Front Door, Molding - Scratch & Dent - Large / (R) Front Fender, Molding - Scratch - Large / Front Bumper, Grille, Lamps - Scratch & Dent - Large / Bonnet, Headlight - Dent - Small</p>
