General Information

Make	Toyota	Model	Vios
YOM	2023	Odo Meter Reading	63,209
Registration No.	NHJ5695	Chassis No.	PA1B18F36P4218909
CC	1.3	Transmission	CVT
Fuel Type	Gas	Type of Body	Sedan
Colour	Blue

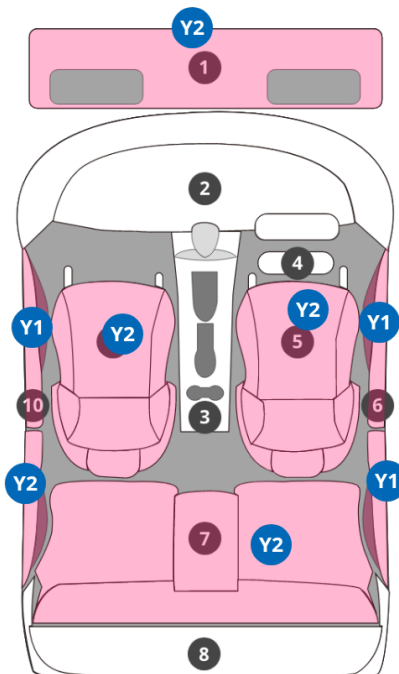
Interior Evaluation : B	Exterior Evaluation : D

<p>a : Cut, Fray d : Loose, Deformed k : Animal Hair s : Smell t : Cigarette Burns x : Defective y : Stain</p>

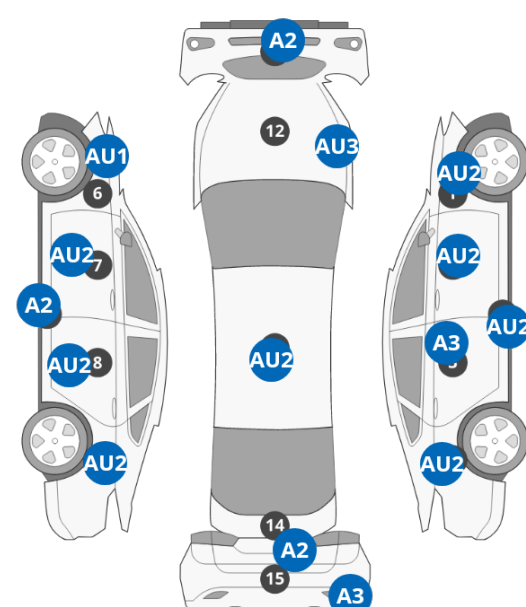
<p>A : Scratch AU : Scratch & Dent B : Modified C : Corrosion G : Stone chip P : Faded S : Rust SC : Rust & Corrosion U : Dent X : Defective Y : Crack, Gap</p>
<p>Remarks (R) Front Seat - Grime - Small / (L) Front Seat - Grime - Small / (L) Front Trim - Grime - Minimal / (R) Front Trim - Grime - Minimal / (L) Rear Trim - Grime - Small / (R) Rear Trim - Grime - Minimal / Rear Seat - Grime - Small / Ceiling - Grime - Small</p>	<p>Remarks Roof - Scratch & Dent - Small / (L) Front Door, Molding - Scratch & Dent - Small / (L) Step, In-panel, Side Spoiler - Scratch - Small / (L) Front Fender, Molding - Scratch & Dent - Minimal / Bonnet, Headlight - Scratch & Dent - Medium / Front Bumper, Grille, Lamps - Scratch - Small / (R) Front Door, Molding - Scratch & Dent - Small / (R) Rear Door, Molding - Scratch - Medium / (R) Rear Fender, Molding - Scratch & Dent - Small / Rear Bumper, Lamps, Panels - Scratch - Medium / Trunk Hood, Rear Gate - Scratch - Small / (L) Rear Fender, Molding - Scratch & Dent - Small / (L) Rear Door, Molding - Scratch & Dent - Small / (R) Front Fender, Molding - Scratch & Dent - Small / (R) Step, In-panel, Side Spoiler - Scratch & Dent - Small</p>
