General Information

Make	Toyota	Model	Vios
YOM	2024	Odo Meter Reading	14,738
Registration No.	NHH5230	Chassis No.	PA1B18F37R4256832
CC	1.3	Transmission	CVT
Fuel Type	Gas	Type of Body	Sedan
Colour	Red Mica Metallic

Body / Panel Condition

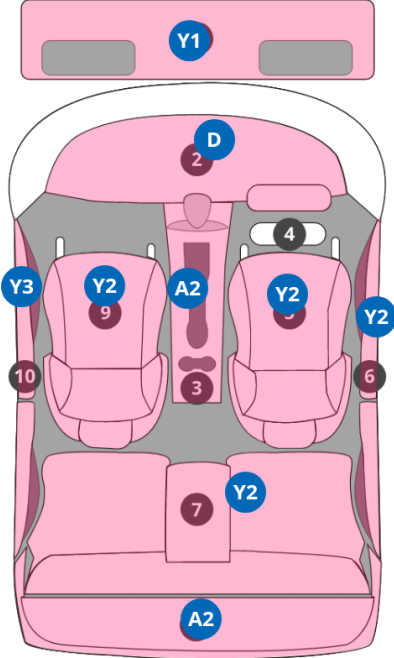
Interior Evaluation : C	Exterior Evaluation : C

<p>a : Cut, Fray d : Loose, Deformed k : Animal Hair s : Smell t : Cigarette Burns x : Defective y : Stain</p>

<p>A : Scratch AU : Scratch & Dent B : Modified C : Corrosion G : Stone chip P : Faded S : Rust SC : Rust & Corrosion U : Dent X : Defective Y : Crack, Gap</p>
<p>Remarks (R) Front Seat - Grime - Small / (R) Front Trim - Grime - Small / Rear Seat - Grime - Small / (L) Front Trim - Grime - Medium / (L) Front Seat - Grime - Small / Dashboard - Traces of Adhesive Tape - Yes / Ceiling - Grime - Minimal / Trunk Room - Worn, Scratch, Cut, Crack - Small / Console, Switchs, Vents - Worn, Scratch, Cut, Crack - Small</p>	<p>Remarks Bonnet, Headlight - Scratch & Dent - Small / (L) Front Fender, Molding - Scratch - Small / Front Bumper, Grille, Lamps - Scratch - Small / (L) Front Door, Molding - Scratch - Medium / (L) Rear Door, Molding - Scratch - Small / Trunk Hood, Rear Gate - Scratch & Dent - Small / Rear Bumper, Lamps, Panels - Dent - Medium / (L) Rear Fender, Molding - Scratch - Minimal / (R) Rear Fender, Molding - Scratch - Minimal / (R) Rear Door, Molding - Scratch - Small / (R) Front Door, Molding - Scratch - Small / (R) Mirror - Scratch - Minimal / (R) Front Fender, Molding - Scratch - Minimal / Roof - Scratch - Small</p>
