General Information

Make	Toyota	Model	Vios
YOM	2025	Odo Meter Reading	40,912
Registration No.	NGC8692	Chassis No.	PA1B18F30R4261838
CC	1.3	Transmission	CVT
Fuel Type	Gas	Type of Body	Sedan
Colour	Red

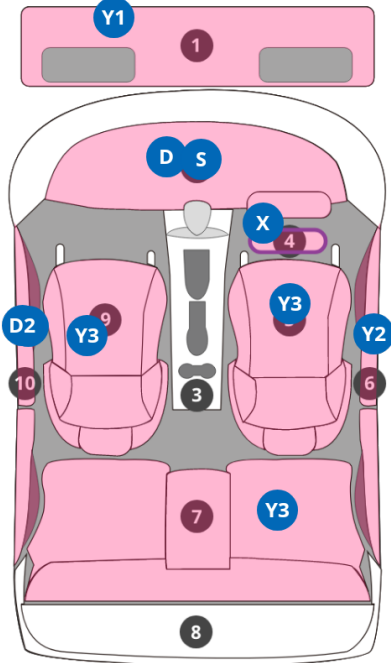
Interior Evaluation : C	Exterior Evaluation : D

<p>a : Cut, Fray d : Loose, Deformed k : Animal Hair s : Smell t : Cigarette Burns x : Defective y : Stain</p>

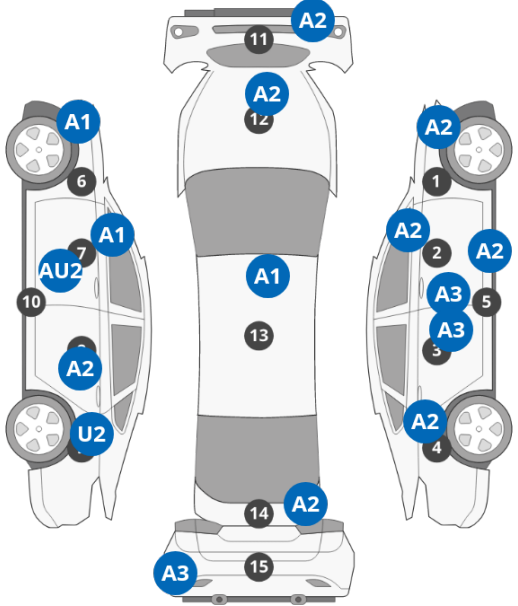
<p>A : Scratch AU : Scratch & Dent B : Modified C : Corrosion G : Stone chip P : Faded S : Rust SC : Rust & Corrosion U : Dent X : Defective Y : Crack, Gap</p>
<p>Remarks Rear Seat - Grime - Medium / (R) Front Seat - Grime - Medium / (L) Front Seat - Grime - Medium / (R) Front Trim - Grime - Small / (L) Front Floor Mat - Missing - Yes / Dashboard - Traces of Adhesive Tape - Yes / (L) Front Trim - Grime - Small / (L) Front Trim - Worked - Small / Overall Interior - Smell - Yes / Ceiling - Grime - Minimal</p>	<p>Remarks (L) Rear Fender - Repair Traces - Yes / (R) Mirror - Scratch - Small / (R) Front Fender, Molding - Scratch - Small / (R) Step, In-panel, Side Spoiler - Scratch - Small / (R) Front Door, Molding - Scratch - Medium / (R) Rear Door, Molding - Scratch - Medium / (R) Rear Fender, Molding - Scratch - Small / Rear Bumper, Lamps, Panels - Scratch - Medium / Trunk Hood, Rear Gate - Scratch - Small / (L) Rear Fender, Molding - Dent - Small / (L) Front Door, Molding - Scratch & Dent - Small / (L) Rear Door, Molding - Scratch - Small / (L) Mirror - Scratch - Minimal / (L) Front Fender, Molding - Scratch - Minimal / Front Bumper, Grille, Lamps - Scratch - Small / Bonnet, Headlight - Scratch - Small / Roof - Scratch - Minimal</p>

<p>Inspector Notes</p>
<p>no warranty booklet, jack and tools, with spare tire, with LTO plate, possible flooding, scratched and cracked tail light, brake light issue, power steering issue due to weak battery</p>
