General Information

Make	Toyota	Model	Vios
YOM	2024	Odo Meter Reading	22,859
Registration No.	NFR7946	Chassis No.	PA1B18F30R4256736
CC	1.3	Transmission	CVT
Fuel Type	Gas	Type of Body	Sedan
Colour	Red Mica Metallic

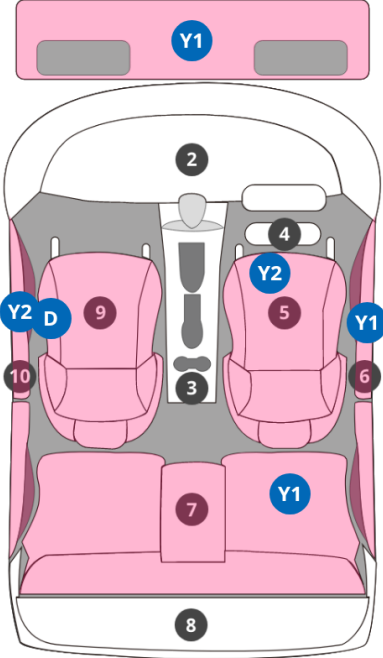
Interior Evaluation : B	Exterior Evaluation : E

<p>a : Cut, Fray d : Loose, Deformed k : Animal Hair s : Smell t : Cigarette Burns x : Defective y : Stain</p>

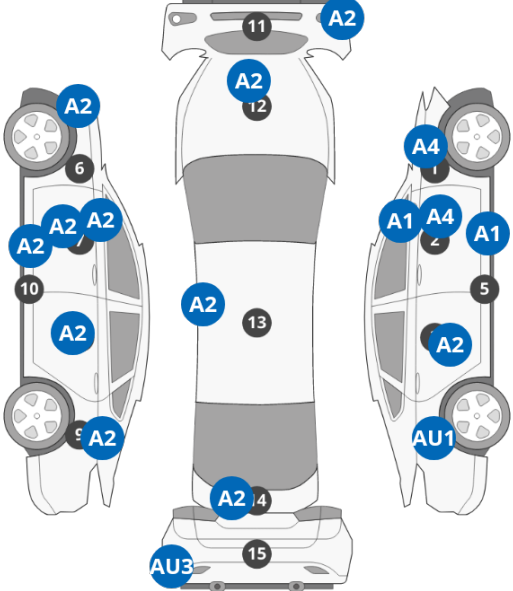
<p>A : Scratch AU : Scratch & Dent B : Modified C : Corrosion G : Stone chip P : Faded S : Rust SC : Rust & Corrosion U : Dent X : Defective Y : Crack, Gap</p>
<p>Remarks (R) Front Seat - Grime - Small / (L) Front Seat - Worn - Yes / (R) Front Trim - Grime - Minimal / (L) Front Trim - Grime - Small / Ceiling - Grime - Minimal / Rear Seat - Grime - Minimal</p>	<p>Remarks (R) Front Fender, Molding - Scratch - Large / (R) Front Door, Molding - Scratch - Large / (R) Mirror - Scratch - Minimal / (R) Step, In-panel, Side Spoiler - Scratch - Minimal / (R) Rear Door, Molding - Scratch - Small / (R) Rear Fender, Molding - Scratch & Dent - Minimal / Rear Bumper, Lamps, Panels - Scratch & Dent - Medium / Trunk Hood, Rear Gate - Scratch - Small / (L) Rear Fender, Molding - Scratch - Small / (L) Front Door, Molding - Scratch - Small / (L) Rear Door, Molding - Scratch - Small / (L) Step, In-panel, Side Spoiler - Scratch - Small / (L) Mirror - Scratch - Small / (L) Front Fender, Molding - Scratch - Small / Front Bumper, Grille, Lamps - Scratch - Small / Bonnet, Headlight - Scratch - Small / Roof - Scratch - Small</p>

<p>Inspector Notes</p>
<p>with warranty booklet, jack and tools, with spare tire, with LTO plate, scratches on tail light,</p>
