General Information

Make	Toyota	Model	Vios
YOM	2025	Odo Meter Reading	1,267
Registration No.	DBU5544	Chassis No.	PA1B18F38S4288386
CC	1.3	Transmission	CVT
Fuel Type	Gas	Type of Body	Sedan
Colour	Blue

Body / Panel Condition

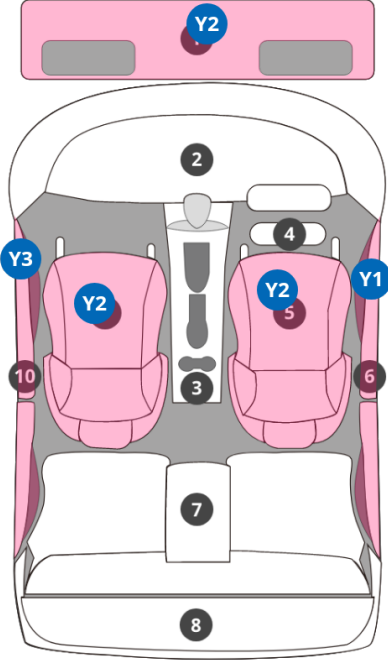
<p>a : Cut, Fray d : Loose, Deformed k : Animal Hair s : Smell t : Cigarette Burns x : Defective y : Stain</p>

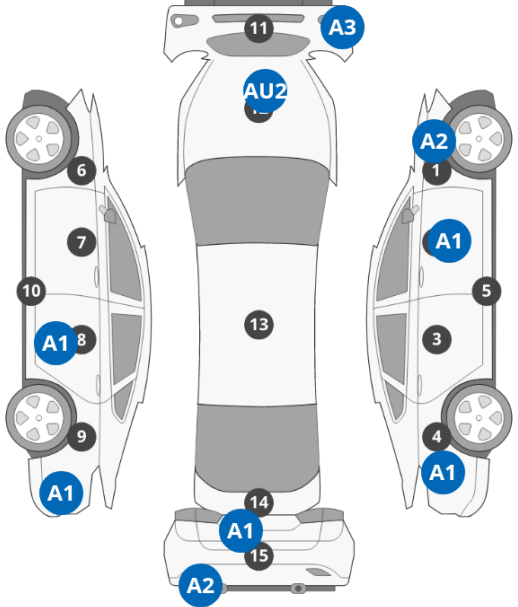
<p>A : Scratch AU : Scratch & Dent B : Modified C : Corrosion G : Stone chip P : Faded S : Rust SC : Rust & Corrosion U : Dent X : Defective Y : Crack, Gap</p>
<p>Remarks (R) Front Seat - Grime - Small / (R) Front Trim - Grime - Minimal / (L) Front Trim - Grime - Medium / (L) Front Seat - Grime - Small / Ceiling - Grime - Small</p>	<p>Remarks (R) Front Fender - Repair Traces - Yes / Bonnet - Repair Traces - Yes / (L) Front Fender - Repair Traces - Yes / Front Bumper, Grille, Lamps - Scratch - Medium / Bonnet, Headlight - Scratch & Dent - Small / (R) Front Fender, Molding - Scratch - Small / (R) Front Door, Molding - Scratch - Minimal / Rear Bumper, Lamps, Panels - Scratch - Small / Trunk Hood, Rear Gate - Scratch - Minimal / (L) Rear Fender, Molding - Scratch - Minimal / (L) Rear Door, Molding - Scratch - Minimal / (R) Rear Fender, Molding - Scratch - Minimal</p>
