General Information

Make	Toyota	Model	Vios
YOM	2025	Odo Meter Reading	31,726
Registration No.	DBQ1895	Chassis No.	PA1B18F39R4268500
CC	1.3	Transmission	CVT
Fuel Type	Gas	Type of Body	Sedan
Colour	Blue

Body / Panel Condition

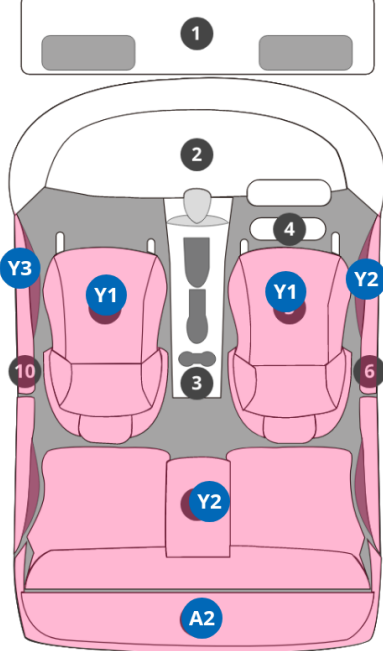
Interior Evaluation : B	Exterior Evaluation : D

<p>a : Cut, Fray d : Loose, Deformed k : Animal Hair s : Smell t : Cigarette Burns x : Defective y : Stain</p>

<p>A : Scratch AU : Scratch & Dent B : Modified C : Corrosion G : Stone chip P : Faded S : Rust SC : Rust & Corrosion U : Dent X : Defective Y : Crack, Gap</p>
<p>Remarks (R) Front Seat - Grime - Minimal / (R) Front Trim - Grime - Small / Rear Seat - Grime - Small / Trunk Room - Worn, Scratch, Cut, Crack - Small / (L) Front Trim - Grime - Medium / (L) Front Seat - Grime - Minimal</p>	<p>Remarks (L) Rear Fender, Molding - Scratch & Dent - Medium / (L) Rear Door, Molding - Scratch - Small / (L) Mirror - Scratch - Minimal / (L) Front Door, Molding - Scratch - Medium / (L) Front Fender, Molding - Scratch - Minimal / Trunk Hood, Rear Gate - Scratch - Minimal / Rear Bumper, Lamps, Panels - Scratch - Small / (R) Rear Fender, Molding - Scratch - Small / (R) Rear Door, Molding - Scratch - Small / (R) Front Door, Molding - Scratch - Small / (R) Mirror - Scratch - Minimal / (R) Front Fender, Molding - Scratch & Dent - Medium / Bonnet, Headlight - Scratch & Dent - Small / Front Bumper, Grille, Lamps - Scratch - Small / Roof - Scratch - Small</p>
