General Information

Make	Toyota	Model	Vios
YOM	2025	Odo Meter Reading	7,017
Registration No.	DBI8980	Chassis No.	PA1B18F36S4291710
CC	1.3	Transmission	CVT
Fuel Type	Gas	Type of Body	Sedan
Colour	Black

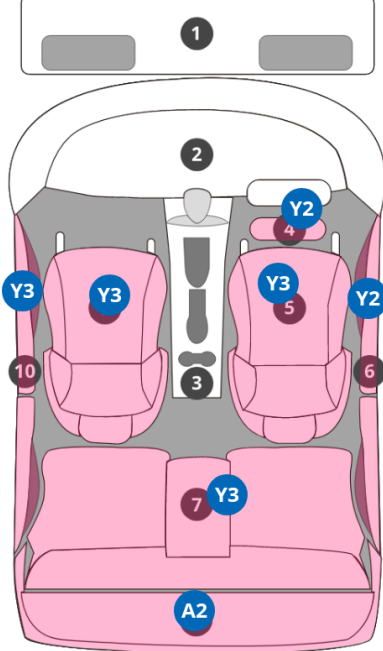
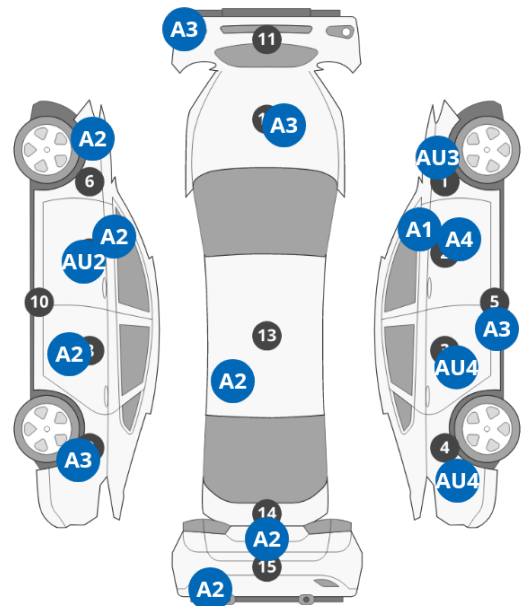
Interior Evaluation :	C	Exterior Evaluation :	E

<p>a : Cut, Fray d : Loose, Deformed k : Animal Hair s : Smell t : Cigarette Burns x : Defective y : Stain</p>		<p>A : Scratch AU : Scratch & Dent B : Modified C : Corrosion G : Stone chip P : Faded S : Rust SC : Rust & Corrosion U : Dent X : Defective Y : Crack, Gap</p>	
<p>Remarks (R) Front Seat - Grime - Medium / (R) Front Trim - Grime - Small / Rear Seat - Grime - Medium / Trunk Room - Worn, Scratch, Cut, Crack - Small / (L) Front Trim - Grime - Medium / (L) Front Seat - Grime - Medium / (L) Front Floor Mat - Grime - Small</p>		<p>Remarks Trunk Hood, Rear Gate - Scratch - Small / Rear Bumper, Lamps, Panels - Scratch - Small / (L) Rear Fender, Molding - Scratch - Medium / (R) Rear Fender, Molding - Scratch & Dent - Large / (R) Rear Door, Molding - Scratch & Dent - Large / (R) Step, In-panel, Side Spoiler - Scratch - Medium / (R) Front Door, Molding - Scratch - Large / (R) Front Fender, Molding - Scratch & Dent - Medium / (R) Mirror - Scratch - Minimal / Bonnet, Headlight - Scratch - Medium / Front Bumper, Grille, Lamps - Scratch - Medium / (L) Front Fender, Molding - Scratch - Small / (L) Mirror - Scratch - Small / (L) Front Door, Molding - Scratch & Dent - Small / (L) Rear Door, Molding - Scratch - Small / Roof - Scratch - Small</p>
