General Information

Make	Toyota	Model	Fortuner
YOM	2020	Odo Meter Reading	35,573
Registration No.	NFZ8243	Chassis No.	MHFJBGS1L1578504
CC	2.4	Transmission	A/T
Fuel Type	Diesel	Type of Body	SUV
Colour	Brown

Body / Panel Condition

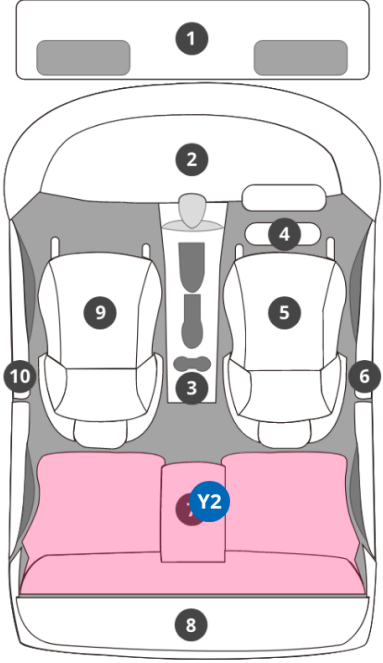
<p>a : Cut, Fray d : Loose, Deformed k : Animal Hair s : Smell t : Cigarette Burns x : Defective y : Stain</p>

<p>A : Scratch AU : Scratch & Dent B : Modified C : Corrosion G : Stone chip P : Faded S : Rust SC : Rust & Corrosion U : Dent X : Defective Y : Crack, Gap</p>
Remarks Rear Seat - Grime - Small	Remarks (R) Front Fender, Molding - Scratch & Dent - Minimal / (R) Front Door, Molding - Scratch & Dent - Medium / (R) Step, In-panel, Side Spoiler - Scratch - Minimal / (R) Rear Door, Molding - Scratch & Dent - Minimal / (R) Rear Fender, Molding - Scratch - Minimal / Rear Bumper, Lamps, Panels - Scratch & Dent - Medium / Trunk Hood, Rear Gate - Scratch - Minimal / (L) Rear Fender, Molding - Scratch - Minimal / (L) Rear Door, Molding - Scratch - Minimal / (L) Step, In-panel, Side Spoiler - Scratch - Minimal / (L) Front Door, Molding - Scratch - Minimal / (L) Mirror - Scratch - Minimal / (L) Front Fender, Molding - Scratch - Minimal / Front Bumper, Grille, Lamps - Scratch - Small / Bonnet, Headlight - Scratch - Minimal

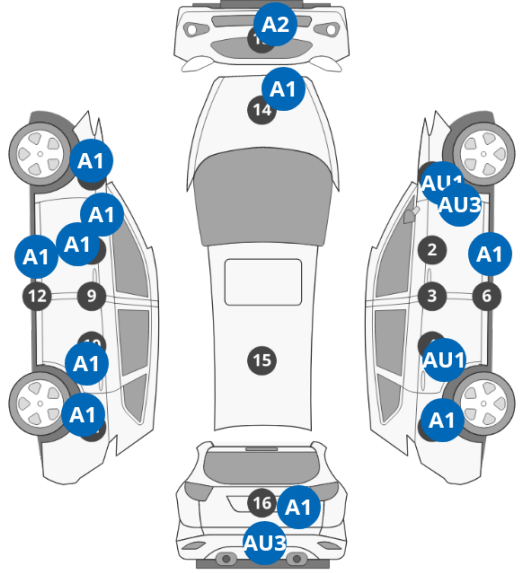
Inspector Notes
With Lto plate, with spare tire, 1key, no warranty booklet, no jack and tools, scratches on headlights
