General Information

Make	Toyota	Model	Innova
YOM	2025	Odo Meter Reading	6,648
Registration No.	BAG7247	Chassis No.	PA2JA8EM7R0149126
CC	2.8	Transmission	A/T
Fuel Type	Diesel	Type of Body	Wagon
Colour	Blackish Red Mica

Body / Panel Condition

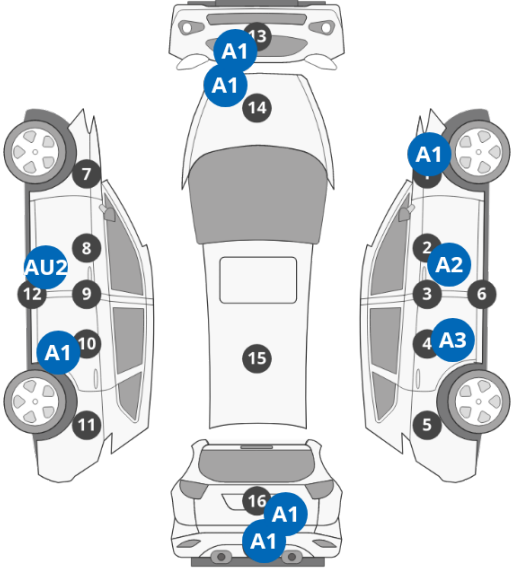
<p>A : Scratch AU : Scratch & Dent B : Modified C : Corrosion G : Stone chip P : Faded S : Rust SC : Rust & Corrosion U : Dent X : Defective Y : Crack, Gap</p>
Remarks Defects not found	Remarks (R) Front Fender, Molding - Scratch - Minimal / (R) Front Door, Molding - Scratch - Small / (R) Rear Door, Molding - Scratch - Medium / Rear Bumper, Lamps, Panels - Scratch - Minimal / Trunk Hood, Rear Gate - Scratch - Minimal / (L) Rear Door, Molding - Scratch - Minimal / (L) Front Door, Molding - Scratch & Dent - Small / Bonnet, Headlight - Scratch - Minimal / Front Bumper, Grille, Lamps - Scratch - Minimal
Frame Evaluation : A	Functional Evaluation : A
Remarks Defects not found	Remarks Defects not found
