## General Information

| Make | Toyota | Model | Vios |

## Body / Panel Condition

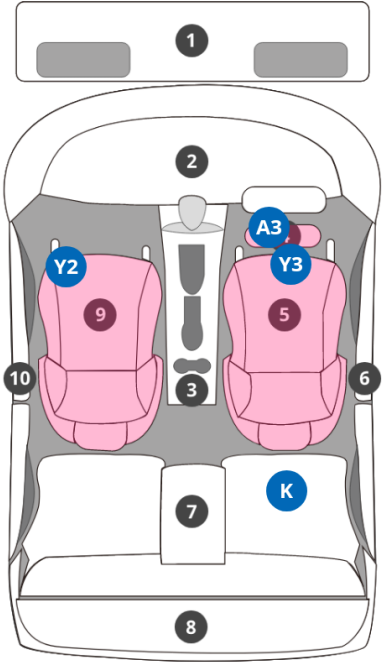
| Interior Evaluation : <b>B</b> | Exterior Evaluation : <b>D</b> |
|---|---|
| <b>Remarks</b><br>Overall Interior - Animal Hair - Yes / (L) Front Floor Mat - Cut, Crack - Medium / (L) Front Seat - Grime - Small / (R) Front Seat - Grime - Medium | <b>Remarks</b><br>Trunk Hood, Rear Gate - Crack, Gap - Medium / Rear Bumper, Lamps, Panels - Scratch & Dent - Large / (L) Rear Door, Molding - Dent - Small / (L) Front Door, Molding - Dent - Small / (R) Rear Door, Molding - Scratch - Medium / (R) Front Fender, Molding - Dent - Small / Member (Bolted) - Dent - Yes / Front Bumper, Grille, Lamps - Scratch & Dent - Large / (L) Front Fender, Molding - Scratch & Dent - Large / (L) Rear Fender, Molding - Dent - Small |
