General Information

Make	Toyota	Model	Rush
YOM	2024	Odo Meter Reading	26,472
Registration No.	CCA6399	Chassis No.	MHK8EFF2P081036
CC	1.5	Transmission	A/T
Fuel Type	Gas	Type of Body	SUV
Colour	White

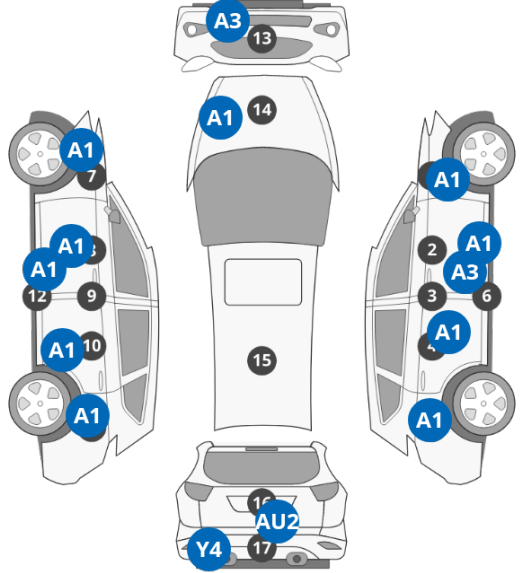
<p>A : Scratch AU : Scratch & Dent B : Modified C : Corrosion G : Stone chip P : Faded S : Rust SC : Rust & Corrosion U : Dent X : Defective Y : Crack, Gap</p>
Remarks Defects not found	Remarks (R) Front Fender, Molding - Scratch - Minimal / (R) Front Door, Molding - Scratch - Medium / (R) Step, In-panel, Side Spoiler - Scratch - Minimal / (R) Rear Door, Molding - Scratch - Minimal / (R) Rear Fender, Molding - Scratch - Minimal / Trunk Hood, Rear Gate - Scratch & Dent - Small / Rear Bumper, Lamps, Panels - Crack, Gap - Large / (L) Rear Fender, Molding - Scratch - Minimal / (L) Rear Door, Molding - Scratch - Minimal / (L) Front Door, Molding - Scratch - Minimal / (L) Step, In-panel, Side Spoiler - Scratch - Minimal / (L) Front Fender, Molding - Scratch - Minimal / Bonnet, Headlight - Scratch - Minimal / Front Bumper, Grille, Lamps - Scratch - Medium

Inspector Notes
With Lto plate, with warranty booklet, with spare tire and jack, 2keys, no tools, scratches on headlights
