General Information

Make	Toyota	Model	Veloz
YOM	2024	Odo Meter Reading	36,392
Registration No.	NHS5563	Chassis No.	MHFAB1BY0R3096476
CC	1.5	Transmission	CVT
Fuel Type	Gas	Type of Body	SUV
Colour	Silver

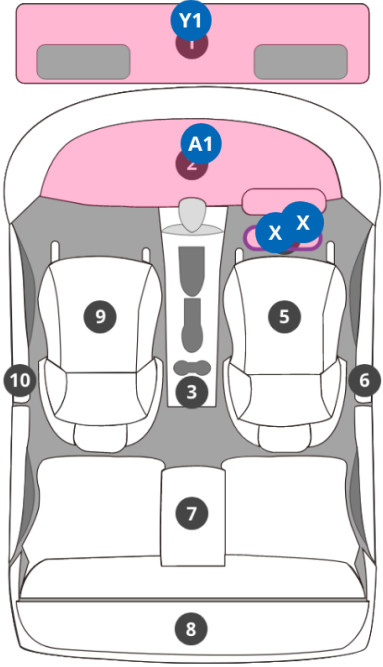
Interior Evaluation : B	Exterior Evaluation : D

<p>a : Cut, Fray d : Loose, Deformed k : Animal Hair s : Smell t : Cigarette Burns x : Defective y : Stain</p>

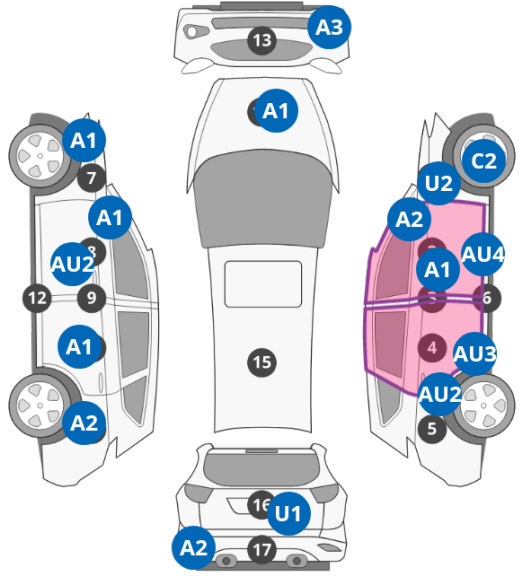
<p>A : Scratch AU : Scratch & Dent B : Modified C : Corrosion G : Stone chip P : Faded S : Rust SC : Rust & Corrosion U : Dent X : Defective Y : Crack, Gap</p>
<p>Remarks Dashboard - Worn, Scratch, Cut, Crack - Minimal / (R) Front Floor Mat - Missing - Yes / (L) Front Floor Mat - Missing - Yes / Mat Other - Missing - Yes / Ceiling - Grime - Minimal</p>	<p>Remarks (R) Rear Door - Repair Traces - Yes / (R) Front Fender, Molding - Dent - Small / (R) Front Door, Molding - Repair mark - Yes / (R) Mirror - Scratch - Small / (R) Front Door, Molding - Scratch - Minimal / (R) Rear Door, Molding - Repair mark - Yes / (R) Rear Door, Molding - Scratch & Dent - Medium / (R) Step, In-panel, Side Spoiler - Scratch & Dent - Large / (R) Rear Fender, Molding - Scratch & Dent - Small / Rear Bumper, Lamps, Panels - Scratch - Small / Trunk Hood, Rear Gate - Dent - Minimal / (L) Rear Fender, Molding - Scratch - Small / (L) Rear Door, Molding - Scratch - Minimal / (L) Front Door, Molding - Scratch & Dent - Small / (L) Mirror - Scratch - Minimal / (L) Front Fender, Molding - Scratch - Minimal / Front Bumper, Grille, Lamps - Scratch - Medium / Bonnet, Headlight - Scratch - Minimal / (R) Front Wheel, Cover - Scratch, Corrosion - Small</p>
