General Information

Make	Toyota	Model	Vios
YOM	2025	Odo Meter Reading	25,405
Registration No.	NGC9320	Chassis No.	PA1B18F35R4262810
CC	1.3	Transmission	CVT
Fuel Type	Gas	Type of Body	Sedan
Colour	Silver

Body / Panel Condition

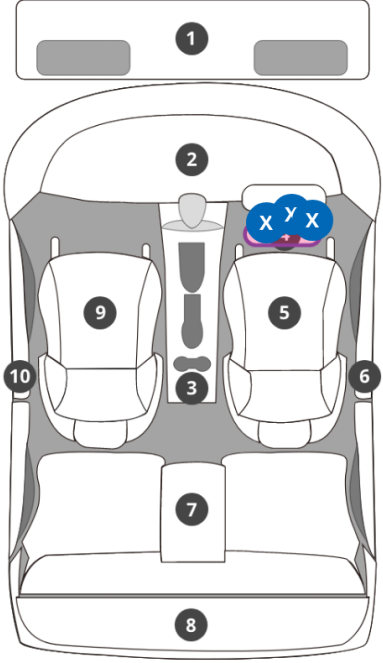
Interior Evaluation : B	Exterior Evaluation : C

<p>a : Cut, Fray d : Loose, Deformed k : Animal Hair s : Smell t : Cigarette Burns x : Defective y : Stain</p>

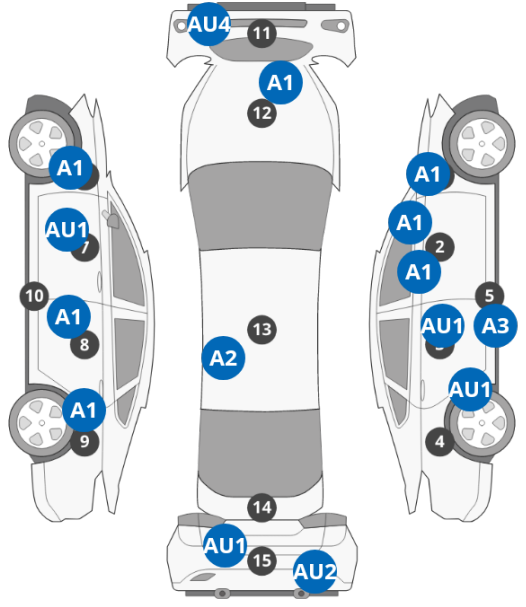
<p>A : Scratch AU : Scratch & Dent B : Modified C : Corrosion G : Stone chip P : Faded S : Rust SC : Rust & Corrosion U : Dent X : Defective Y : Crack, Gap</p>
<p>Remarks (R) Front Floor Mat - Missing - Yes / (L) Front Floor Mat - Missing - Yes / Mat Other - Missing - Yes</p>	<p>Remarks (R) Front Fender, Molding - Scratch - Minimal / (R) Mirror - Scratch - Minimal / (R) Front Door, Molding - Scratch - Minimal / (R) Rear Door, Molding - Scratch & Dent - Minimal / (R) Step, In-panel, Side Spoiler - Scratch - Medium / (R) Rear Fender, Molding - Scratch & Dent - Minimal / Trunk Hood, Rear Gate - Scratch & Dent - Minimal / Rear Bumper, Lamps, Panels - Scratch & Dent - Small / (L) Rear Fender, Molding - Scratch - Minimal / (L) Rear Door, Molding - Scratch - Minimal / (L) Front Door, Molding - Scratch & Dent - Minimal / (L) Front Fender, Molding - Scratch - Minimal / Bonnet, Headlight - Scratch - Minimal / Roof - Scratch - Small / Front Bumper, Grille, Lamps - Scratch & Dent - Large</p>

<p>Inspector Notes</p>
<p>With Lto plate, with warranty booklet, with spare tire, with jack and tools, 1key, scratches on headlights and taillights</p>
