General Information

Body / Panel Condition

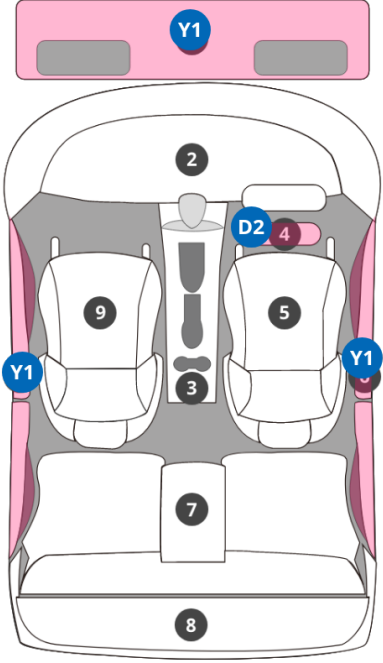
Interior Evaluation : A	Exterior Evaluation : D

<p>a : Cut, Fray d : Loose, Deformed k : Animal Hair s : Smell t : Cigarette Burns x : Defective y : Stain</p>

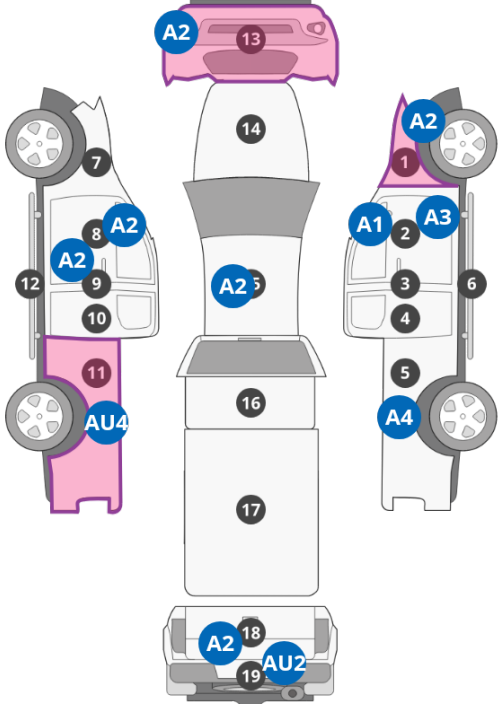
<p>A : Scratch AU : Scratch & Dent B : Modified C : Corrosion G : Stone chip P : Faded S : Rust SC : Rust & Corrosion U : Dent X : Defective Y : Crack, Gap</p>
<p>Remarks (L) Front Floor Mat - Worked - Small / Ceiling - Grime - Minimal / (L) Front Trim - Grime - Minimal / (R) Front Trim - Grime - Minimal</p>	<p>Remarks (L) Front Door - Repair Traces - Yes / (L) Side Gate - Repair mark - Yes / (L) Side Gate - Scratch & Dent - Large / (L) Front Door, Molding - Scratch - Small / Rear Bumper, Lamps, Panels - Scratch & Dent - Small / Rear Gate - Scratch - Small / (R) Side Gate - Scratch - Large / (R) Front Door, Molding - Scratch - Medium / (R) Front Fender, Molding - Repair mark - Yes / (R) Front Fender, Molding - Scratch - Small / Front Bumper, Grille, Lamps - Repair mark - Yes / Front Bumper, Grille, Lamps - Scratch - Small / (L) Mirror - Scratch - Small / (R) Mirror - Scratch - Minimal / Roof - Scratch - Small</p>
