## General Information

<b>Make</b>	Toyota	<b>Model</b>	Vios
<b>YOM</b>	2025	<b>Odo Meter Reading</b>	4,166
<b>Registration No.</b>	NKP9445	<b>Chassis No.</b>	PA1B18F30S4287166
<b>CC</b>	1.3	<b>Transmission</b>	CVT
<b>Fuel Type</b>	Gas	<b>Type of Body</b>	Sedan
<b>Colour</b>	Black

## Body / Panel Condition

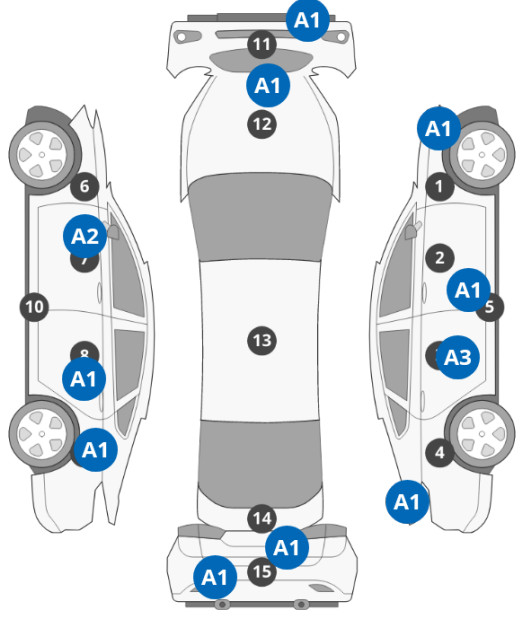
<b>Interior Evaluation :</b>	<b>A</b>	<b>Exterior Evaluation :</b>	<b>B</b>

<p><b>a</b> : Cut, Fray <b>d</b> : Loose, Deformed <b>k</b> : Animal Hair <b>s</b> : Smell <b>t</b> : Cigarette Burns <b>x</b> : Defective <b>y</b> : Stain</p>		<p><b>A</b> : Scratch <b>AU</b> : Scratch &amp; Dent <b>B</b> : Modified <b>C</b> : Corrosion <b>G</b> : Stone chip <b>P</b> : Faded <b>S</b> : Rust <b>SC</b> : Rust &amp; Corrosion <b>U</b> : Dent <b>X</b> : Defective <b>Y</b> : Crack, Gap</p>	
<p><b>Remarks</b> Defects not found</p>		<p><b>Remarks</b> (R) Front Fender, Molding - Scratch - Minimal / (R) Front Door, Molding - Scratch - Minimal / (R) Rear Door, Molding - Scratch - Medium / (R) Rear Fender, Molding - Scratch - Minimal / Rear Bumper, Lamps, Panels - Scratch - Minimal / Trunk Hood, Rear Gate - Scratch - Minimal / (L) Rear Fender, Molding - Scratch - Minimal / (L) Rear Door, Molding - Scratch - Minimal / (L) Front Door, Molding - Scratch - Small / Bonnet, Headlight - Scratch - Minimal / Front Bumper, Grille, Lamps - Scratch - Minimal</p>

<b>Inspector Notes</b>
With Lto plate, with warranty booklet, with jack and tools, 3keys, no spare tire, scratches on headlights and taillights
