## General Information

| Make | Toyota | Model | Vios |

## Body / Panel Condition

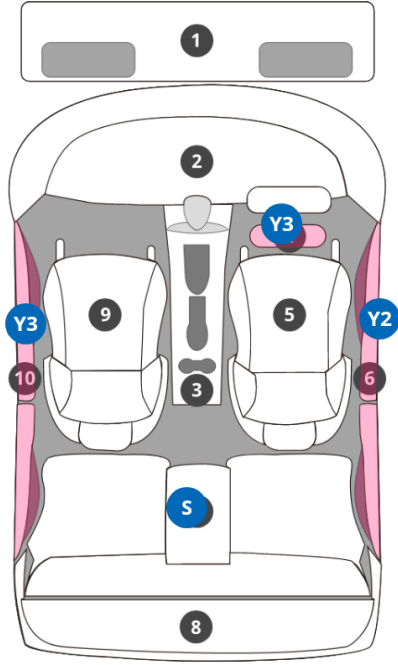
| Interior Evaluation : <b>B</b> | Exterior Evaluation : <b>D</b> |
| <b>Remarks</b><br>Mat Other - Grime - Medium / (L) Front Trim - Grime - Medium / (R) Front Trim - Grime - Small / Overall Interior - Smell - Yes | <b>Remarks</b><br>Front Bumper, Grille, Lamps - Scratch & Dent - Large / (L) Step, In-panel, Side Spoiler - Dent - Small / (L) Rear Door, Molding - Scratch & Dent - Small / (L) Rear Fender, Molding - Scratch - Medium / Rear Bumper, Lamps, Panels - Scratch - Medium / (R) Rear Fender, Molding - Dent - Minimal / (R) Rear Door, Molding - Scratch & Dent - Large / Bonnet, Headlight - Dent - Small / (L) Front Fender, Molding - Scratch & Dent - Medium / Trunk Hood, Rear Gate - Dent - Small |
