General Information

| Make | Toyota | Model | Vios |
| Registration No. | GBK1340 | Chassis No. | PA1B18F32S4285838 |

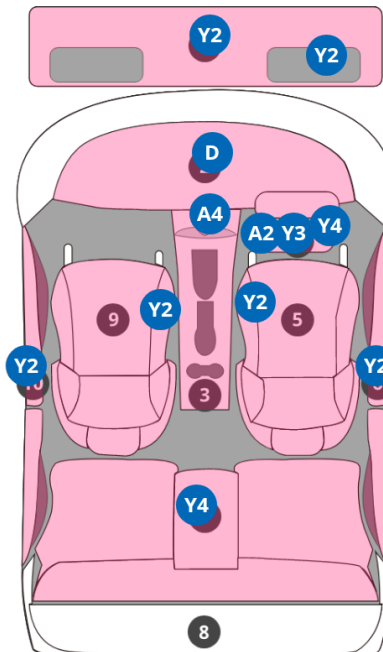
| Interior Evaluation : E | Exterior Evaluation : E |

| <p>a : Cut, Fray d : Loose, Deformed k : Animal Hair s : Smell t : Cigarette Burns x : Defective y : Stain</p> | <p>A : Scratch AU : Scratch & Dent B : Modified C : Corrosion G : Stone chip P : Faded S : Rust SC : Rust & Corrosion U : Dent X : Defective Y : Crack, Gap</p> |
| <p>Remarks (L) Front Floor Mat - Cut, Crack - Small / (R) Front Floor Mat - Grime - Large / Mat Other - Grime - Medium / Rear Seat - Grime - Large / (R) Front Seat - Grime - Small / (L) Front Seat - Grime - Small / Console, Switches, Vents - Worn, Scratch, Cut, Crack - Large / Sunvisor, Sunglass Holder - Grime - Small / Ceiling - Grime - Small / Dashboard - Traces of Adhesive Tape - Yes / (L) Front Trim - Grime - Small / (R) Front Trim - Grime - Small</p> | <p>Remarks (L) Rear Fender, Molding - Scratch - Medium / (L) Rear Door, Molding - Scratch - Small / (L) Front Door, Molding - Scratch - Small / (L) Mirror - Scratch - Small / (L) Front Fender, Molding - Scratch - Small / Trunk Hood, Rear Gate - Scratch & Dent - Small / Trunk Hood, Rear Gate - Modified - Small / Rear Bumper, Lamps, Panels - Scratch - Medium / (R) Rear Fender, Molding - Scratch & Dent - Small / (R) Rear Door, Molding - Scratch - Small / (R) Step, In-panel, Side Spoiler - Scratch & Dent - Medium / (R) Front Door, Molding - Scratch - Medium / (R) Mirror - Scratch - Small / (R) Front Fender, Molding - Scratch - Small / Front Bumper, Grille, Lamps - Scratch & Dent - Large / Bonnet, Headlight - Scratch - Large / Roof - Scratch - Small</p> |
