General Information

Make	Toyota	Model	Wigo
YOM	2023	Odo Meter Reading	22,848
Registration No.	GBA9714	Chassis No.	MHKAA1BC1PJ003370
CC	1.0	Transmission	CVT
Fuel Type	Gas	Type of Body	Hatchback
Colour	Yellow

Body / Panel Condition

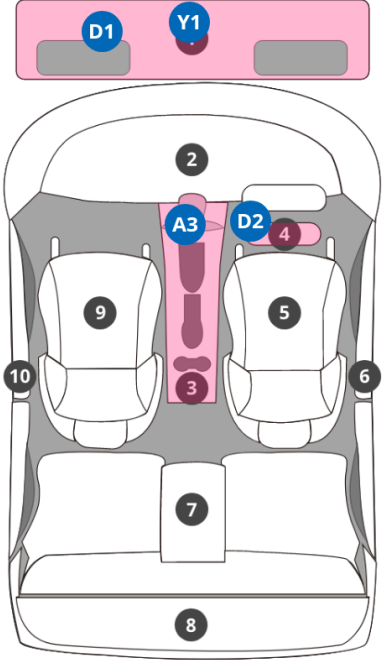
Interior Evaluation : B	Exterior Evaluation : E

<p>a : Cut, Fray d : Loose, Deformed k : Animal Hair s : Smell t : Cigarette Burns x : Defective y : Stain</p>

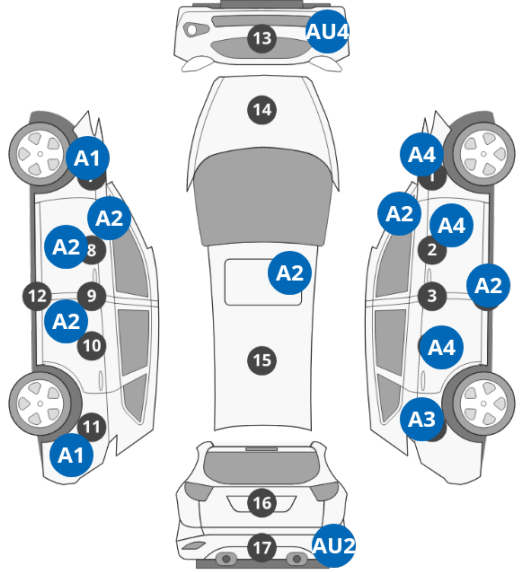
<p>A : Scratch AU : Scratch & Dent B : Modified C : Corrosion G : Stone chip P : Faded S : Rust SC : Rust & Corrosion U : Dent X : Defective Y : Crack, Gap</p>
<p>Remarks Ceiling - Grime - Minimal / Sunvisor, Sunglass Holder - Crinkle - Minimal / (L) Front Floor Mat - Worked - Small / Console, Switchs, Vents - Worn, Scratch, Cut, Crack - Medium</p>	<p>Remarks (L) Front Fender, Molding - Scratch - Minimal / (R) Front Fender, Molding - Scratch - Large / (R) Mirror - Scratch - Small / (R) Front Door, Molding - Scratch - Large / (R) Rear Door, Molding - Scratch - Large / (R) Step, In-panel, Side Spoiler - Scratch - Small / (R) Rear Fender, Molding - Scratch - Medium / (L) Rear Fender, Molding - Scratch - Minimal / Rear Bumper, Lamps, Panels - Scratch & Dent - Small / (L) Rear Door, Molding - Scratch - Small / (L) Mirror - Scratch - Small / (L) Front Door, Molding - Scratch - Small / Front Bumper, Grille, Lamps - Scratch & Dent - Large / Roof - Scratch - Small</p>

<p>Inspector Notes</p>
<p>Gap at front bumper. Without warranty booklet and tools. With spare tire, jack, and seat cover. 1 key. With LTO plate.</p>
