General Information

Make	Toyota	Model	Vios
YOM	2024	Odo Meter Reading	39,974
Registration No.	DBF7192	Chassis No.	PA1B18F30R4250709
CC	1.3	Transmission	CVT
Fuel Type	Gas	Type of Body	Sedan
Colour	Blue

Body / Panel Condition

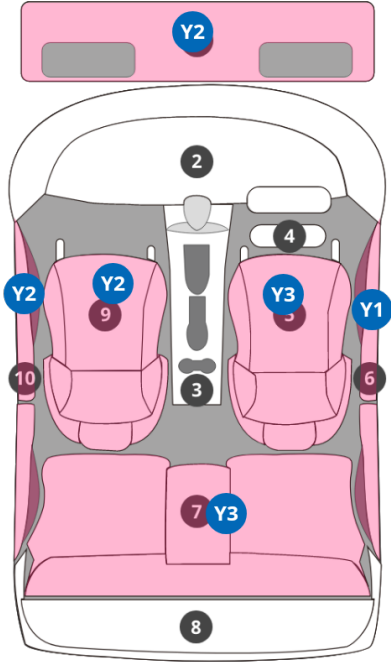
Interior Evaluation : B	Exterior Evaluation : E

<p>a : Cut, Fray d : Loose, Deformed k : Animal Hair s : Smell t : Cigarette Burns x : Defective y : Stain</p>

<p>A : Scratch AU : Scratch & Dent B : Modified C : Corrosion G : Stone chip P : Faded S : Rust SC : Rust & Corrosion U : Dent X : Defective Y : Crack, Gap</p>
<p>Remarks (R) Front Seat - Grime - Medium / (R) Front Trim - Grime - Minimal / Rear Seat - Grime - Medium / (L) Front Trim - Grime - Small / (L) Front Seat - Grime - Small / Ceiling - Grime - Small</p>	<p>Remarks (L) Rear Door, Molding - Scratch & Dent - Small / (L) Front Door, Molding - Scratch - Small / (L) Mirror - Scratch - Minimal / (L) Front Fender, Molding - Scratch - Minimal / Bonnet, Headlight - Scratch - Small / Front Bumper, Grille, Lamps - Scratch - Large / (R) Front Fender, Molding - Scratch & Dent - Medium / (R) Front Door, Molding - Scratch & Dent - Medium / (R) Step, In-panel, Side Spoiler - Scratch & Dent - Medium / (R) Rear Door, Molding - Scratch & Dent - Large / (R) Mirror - Scratch - Minimal / (R) Rear Fender, Molding - Scratch & Dent - Minimal / Trunk Hood, Rear Gate - Scratch - Small / Rear Bumper, Lamps, Panels - Scratch - Medium / Roof - Scratch - Small / (L) Rear Fender, Molding - Scratch - Minimal</p>
