General Information

Make	Toyota	Model	Vios
YOM	2024	Odo Meter Reading	49,201
Registration No.	DBN5341	Chassis No.	PA1B18F39P4229905
CC	1.3	Transmission	CVT
Fuel Type	Gas	Type of Body	Sedan
Colour	Red Mica Metallic

Body / Panel Condition

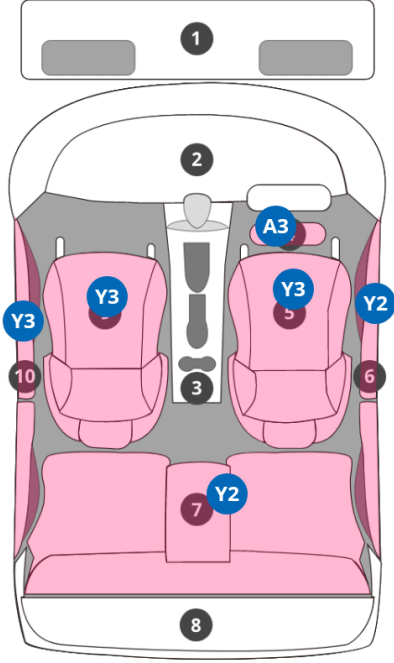
Interior Evaluation : C	Exterior Evaluation : E

<p>a : Cut, Fray d : Loose, Deformed k : Animal Hair s : Smell t : Cigarette Burns x : Defective y : Stain</p>

<p>A : Scratch AU : Scratch & Dent B : Modified C : Corrosion G : Stone chip P : Faded S : Rust SC : Rust & Corrosion U : Dent X : Defective Y : Crack, Gap</p>
<p>Remarks (R) Front Seat - Grime - Medium / (L) Front Floor Mat - Cut, Crack - Medium / (L) Front Seat - Grime - Medium / Rear Seat - Grime - Small / (L) Front Trim - Grime - Medium / (R) Front Trim - Grime - Small</p>	<p>Remarks (R) Rear Fender - Repair Traces - Yes / Roof - Scratch & Dent - Small / (L) Rear Fender, Molding - Scratch & Dent - Large / (L) Front Fender, Molding - Scratch & Dent - Minimal / (L) Front Door, Molding - Scratch & Dent - Small / (L) Rear Door, Molding - Scratch & Dent - Small / Trunk Hood, Rear Gate - Scratch & Dent - Small / Rear Bumper, Lamps, Panels - Scratch - Small / (R) Rear Fender, Molding - Repair mark - Yes / (R) Rear Fender, Molding - Scratch & Dent - Medium / (R) Rear Door, Molding - Scratch & Dent - Small / (R) Front Door, Molding - Scratch & Dent - Medium / (R) Step, In-panel, Side Spoiler - Scratch & Dent - Minimal / (R) Front Fender, Molding - Scratch & Dent - Small / Bonnet, Headlight - Scratch & Dent - Small / Front Bumper, Grille, Lamps - Scratch - Medium / (L) Step, In-panel, Side Spoiler - Scratch & Dent - Small</p>

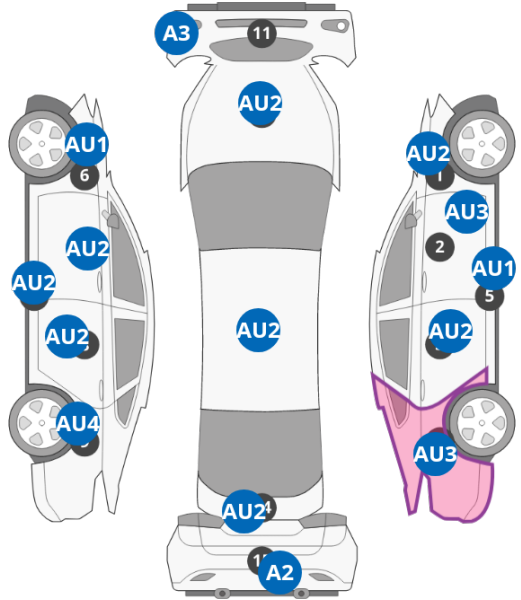
<p>Inspector Notes</p>
<p>with LTO plate, with spare tire, with tools & jack, no warranty and manual booklet, no reverse camera, scratches on taillight and headlight.</p>
