General Information

Make	Toyota	Model	Vios
YOM	2024	Odo Meter Reading	12,176
Registration No.	DBO8259	Chassis No.	PA1B18F37R4257429
CC	1.3	Transmission	CVT
Fuel Type	Gas	Type of Body	Sedan
Colour	Red

Body / Panel Condition

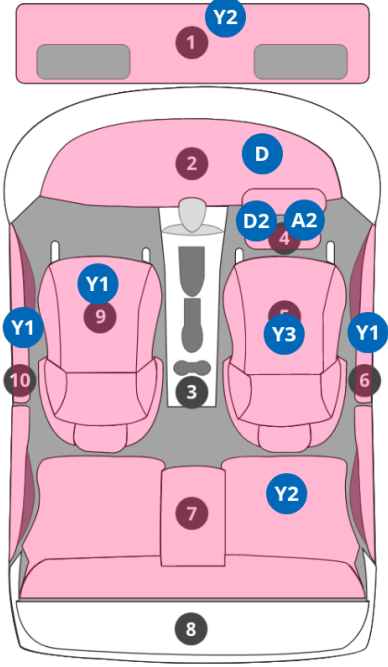
Interior Evaluation : B	Exterior Evaluation : D

<p>a : Cut, Fray d : Loose, Deformed k : Animal Hair s : Smell t : Cigarette Burns x : Defective y : Stain</p>

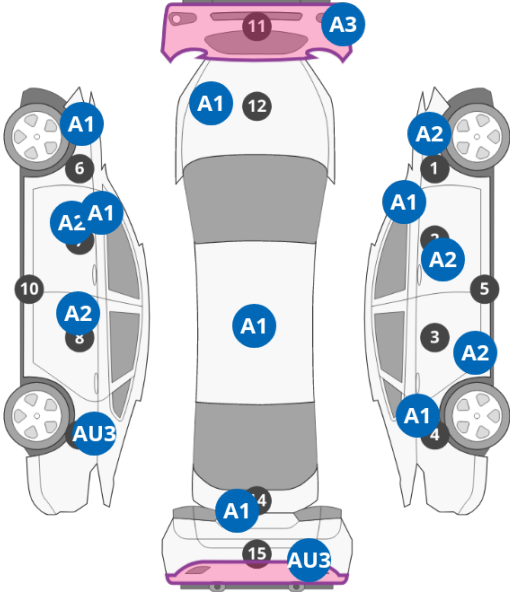
<p>A : Scratch AU : Scratch & Dent B : Modified C : Corrosion G : Stone chip P : Faded S : Rust SC : Rust & Corrosion U : Dent X : Defective Y : Crack, Gap</p>
Remarks (L) Front Seat - Grime - Minimal / (R) Front Seat - Grime - Medium / (L) Front Trim - Grime - Minimal / (R) Front Trim - Grime - Minimal / (L) Front Floor Mat - Worked - Small / Rear Seat - Grime - Small / (R) Front Floor Mat - Cut, Crack - Small / Dashboard - Traces of Adhesive Tape - Yes / Ceiling - Grime - Small	Remarks Trunk Hood, Rear Gate - Repair Traces - Yes / Front Bumper, Grille, Lamps - Repair mark - Yes / Rear Bumper, Lamps, Panels - Repair mark - Yes / (R) Mirror - Scratch - Minimal / (R) Front Fender, Molding - Scratch - Small / (R) Front Door, Molding - Scratch - Small / (R) Rear Door, Molding - Scratch - Small / (R) Rear Fender, Molding - Scratch - Minimal / Rear Bumper, Lamps, Panels - Scratch & Dent - Medium / Trunk Hood, Rear Gate - Scratch - Minimal / (L) Rear Fender, Molding - Scratch & Dent - Medium / (L) Rear Door, Molding - Scratch - Small / (L) Front Door, Molding - Scratch - Small / (L) Mirror - Scratch - Minimal / Front Bumper, Grille, Lamps - Scratch - Medium / (L) Front Fender, Molding - Scratch - Minimal / Bonnet, Headlight - Scratch - Minimal / Roof - Scratch - Minimal
