General Information

Make	Toyota	Model	Vios
YOM	2025	Odo Meter Reading	18,190
Registration No.	DBQ8158	Chassis No.	PA1B18F39R4272451
CC	1.3	Transmission	CVT
Fuel Type	Gas	Type of Body	Sedan
Colour	Red

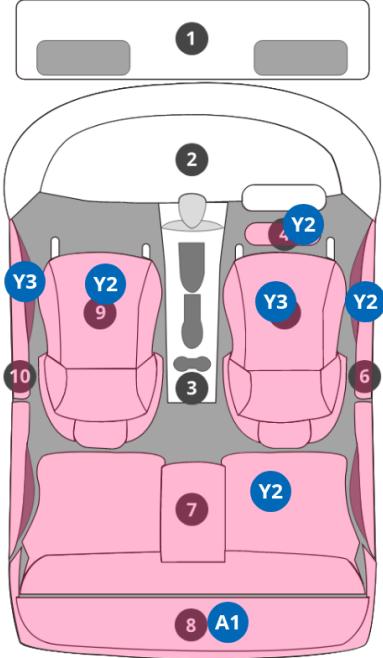
Interior Evaluation : B	Exterior Evaluation : D

<p>a : Cut, Fray d : Loose, Deformed k : Animal Hair s : Smell t : Cigarette Burns x : Defective y : Stain</p>

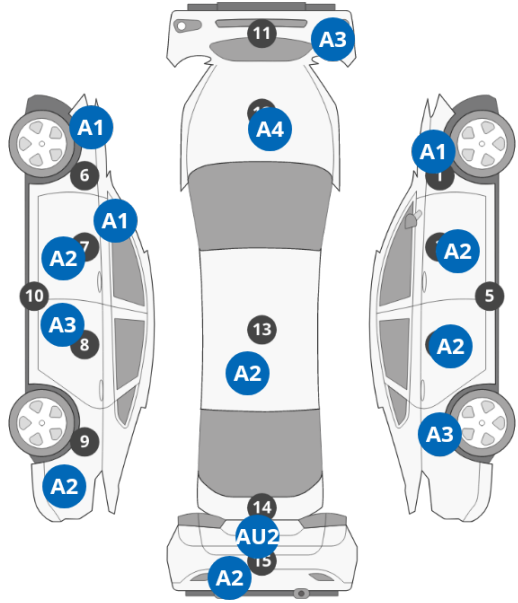
<p>A : Scratch AU : Scratch & Dent B : Modified C : Corrosion G : Stone chip P : Faded S : Rust SC : Rust & Corrosion U : Dent X : Defective Y : Crack, Gap</p>
<p>Remarks (R) Front Seat - Grime - Medium / (R) Front Trim - Grime - Small / Rear Seat - Grime - Small / Trunk Room - Worn, Scratch, Cut, Crack - Minimal / (L) Front Trim - Grime - Medium / (L) Front Seat - Grime - Small / (L) Front Floor Mat - Grime - Small</p>	<p>Remarks Bonnet, Headlight - Scratch - Large / (R) Rear Fender, Molding - Scratch - Medium / (R) Rear Door, Molding - Scratch - Small / (R) Front Door, Molding - Scratch - Small / (R) Front Fender, Molding - Scratch - Minimal / Trunk Hood, Rear Gate - Scratch & Dent - Small / Rear Bumper, Lamps, Panels - Scratch - Small / (L) Rear Fender, Molding - Scratch - Small / (L) Rear Door, Molding - Scratch - Medium / (L) Front Door, Molding - Scratch - Small / (L) Mirror - Scratch - Minimal / Roof - Scratch - Small / Front Bumper, Grille, Lamps - Scratch - Medium / (L) Front Fender, Molding - Scratch - Minimal</p>
