General Information

Make	Toyota	Model	Wigo
YOM	2024	Odo Meter Reading	19,172
Registration No.	DBQ1625	Chassis No.	MHKAA1BC1RJ022438
CC	1.0	Transmission	CVT
Fuel Type	Gas	Type of Body	Hatchback
Colour	Gray

Body / Panel Condition

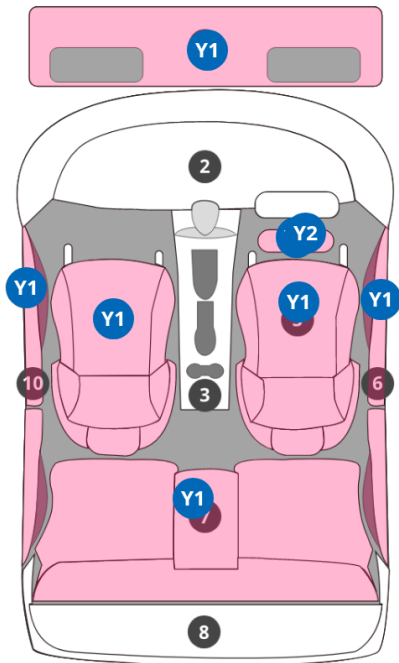
Interior Evaluation : B	Exterior Evaluation : D

<p>a : Cut, Fray d : Loose, Deformed k : Animal Hair s : Smell t : Cigarette Burns x : Defective y : Stain</p>

<p>A : Scratch AU : Scratch & Dent B : Modified C : Corrosion G : Stone chip P : Faded S : Rust SC : Rust & Corrosion U : Dent X : Defective Y : Crack, Gap</p>
<p>Remarks (L) Front Floor Mat - Grime - Medium / (R) Front Floor Mat - Grime - Small / (L) Front Trim - Grime - Minimal / (R) Front Trim - Grime - Minimal / Ceiling - Grime - Minimal / (L) Front Seat - Grime - Minimal / (R) Front Seat - Grime - Minimal / Rear Seat - Grime - Minimal</p>	<p>Remarks (L) Step, In-panel, Side Spoiler - Scratch & Dent - Medium / (L) Rear Door, Molding - Scratch - Medium / (L) Rear Fender, Molding - Scratch & Dent - Small / Trunk Hood, Rear Gate - Scratch & Dent - Small / Rear Bumper, Lamps, Panels - Scratch - Small / Roof - Scratch & Dent - Small / (R) Rear Fender, Molding - Scratch & Dent - Small / (R) Rear Door, Molding - Scratch & Dent - Small / (R) Front Door, Molding - Scratch & Dent - Small / (R) Front Fender, Molding - Scratch & Dent - Small / Bonnet, Headlight - Scratch & Dent - Medium / (L) Front Fender, Molding - Scratch & Dent - Small / (L) Front Door, Molding - Scratch & Dent - Small / (R) Step, In-panel, Side Spoiler - Scratch - Small / Front Bumper, Grille, Lamps - Scratch - Small</p>
