General Information

Make	Toyota	Model	Hilux Tamaraw
YOM	2025	Odo Meter Reading	12,547
Registration No.	EAH5157	Chassis No.	PAHACACAXS6425883
CC	2.4	Transmission	M/T
Fuel Type	Diesel	Type of Body	Utility Passenger
Colour	White

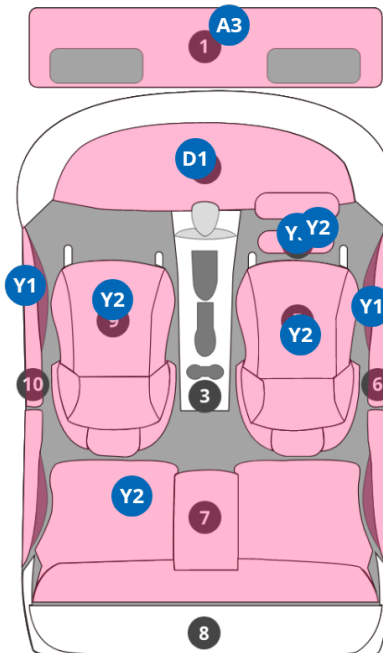
Interior Evaluation : B	Exterior Evaluation : D

<p>a : Cut, Fray d : Loose, Deformed k : Animal Hair s : Smell t : Cigarette Burns x : Defective y : Stain</p>

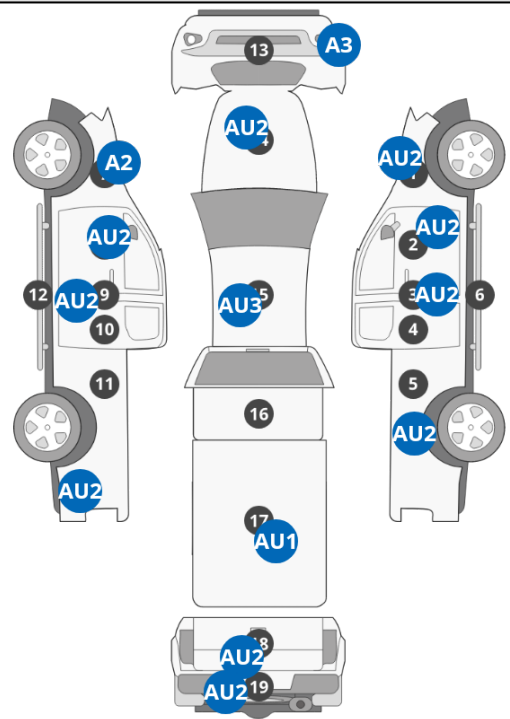
<p>A : Scratch AU : Scratch & Dent B : Modified C : Corrosion G : Stone chip P : Faded S : Rust SC : Rust & Corrosion U : Dent X : Defective Y : Crack, Gap</p>
<p>Remarks (L) Front Seat - Grime - Small / (R) Front Seat - Grime - Small / (L) Front Trim - Grime - Minimal / (R) Front Trim - Grime - Minimal / Dashboard - Worked - Minimal / Ceiling - Cut, Crack - Medium / Rear Seat - Grime - Small / (L) Front Floor Mat - Grime - Medium / (R) Front Floor Mat - Grime - Small</p>	<p>Remarks (L) Front Door, Molding - Scratch & Dent - Small / (L) Front Fender, Molding - Scratch - Small / Front Bumper, Grille, Lamps - Scratch - Medium / (R) Front Fender, Molding - Scratch & Dent - Small / Bonnet, Headlight - Scratch & Dent - Small / (R) Front Door, Molding - Scratch & Dent - Small / Roof - Scratch & Dent - Medium / (R) Side Gate - Scratch & Dent - Small / Rear Gate - Scratch & Dent - Small / Rear Bumper, Lamps, Panels - Scratch & Dent - Small / (L) Side Gate - Scratch & Dent - Small / (L) Center Panel - Scratch & Dent - Small / (R) Center Panel - Scratch & Dent - Small / Cargo Bed Floor - Scratch & Dent - Minimal</p>

<p>Inspector Notes</p>
<p>with LTO plate, with spare tire, with spare key, with warranty and manual booklet, scratches on taillight and headlight.</p>
