General Information

Make	Toyota	Model	Vios
YOM	2024	Odo Meter Reading	11,628
Registration No.	NFF3062	Chassis No.	PA1B18F3XP4234711
CC	1.3	Transmission	CVT
Fuel Type	Gas	Type of Body	Sedan
Colour	Blue

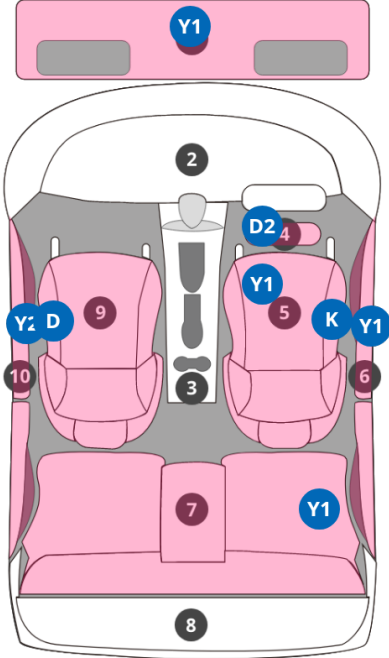
Interior Evaluation : B	Exterior Evaluation : C

<p>a : Cut, Fray d : Loose, Deformed k : Animal Hair s : Smell t : Cigarette Burns x : Defective y : Stain</p>

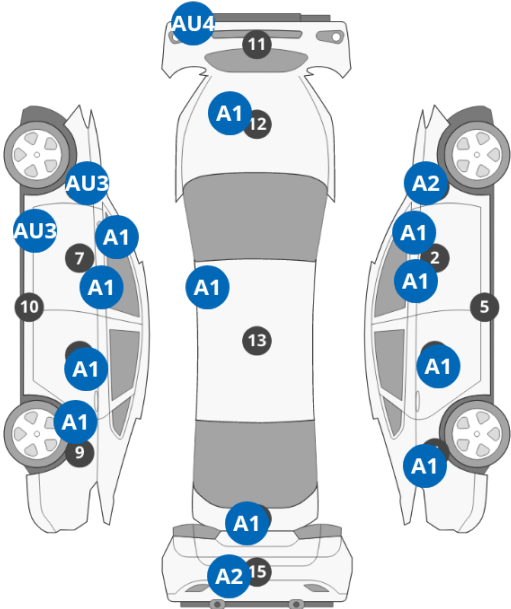
<p>A : Scratch AU : Scratch & Dent B : Modified C : Corrosion G : Stone chip P : Faded S : Rust SC : Rust & Corrosion U : Dent X : Defective Y : Crack, Gap</p>
<p>Remarks (R) Front Trim - Grime - Minimal / (L) Front Trim - Grime - Small / (L) Front Seat - Worn - Yes / (R) Front Seat - Grime - Minimal / Overall Interior - Animal Hair - Yes / Rear Seat - Grime - Minimal / (L) Front Floor Mat - Worked - Small / Ceiling - Grime - Minimal</p>	<p>Remarks (R) Front Fender, Molding - Scratch - Small / (R) Mirror - Scratch - Minimal / (R) Front Door, Molding - Scratch - Minimal / (R) Rear Door, Molding - Scratch - Minimal / (R) Rear Fender, Molding - Scratch - Minimal / Rear Bumper, Lamps, Panels - Scratch - Small / Trunk Hood, Rear Gate - Scratch - Minimal / (L) Rear Fender, Molding - Scratch - Minimal / (L) Step, In-panel, Side Spoiler - Scratch & Dent - Medium / (L) Rear Door, Molding - Scratch - Minimal / (L) Front Fender, Molding - Scratch & Dent - Medium / (L) Mirror - Scratch - Minimal / (L) Front Door, Molding - Scratch - Minimal / Front Bumper, Grille, Lamps - Scratch & Dent - Large / Bonnet, Headlight - Scratch - Minimal / Roof - Scratch - Minimal</p>
