General Information

Make	Toyota	Model	Vios
YOM	2023	Odo Meter Reading	110,917
Registration No.	NHC1051	Chassis No.	PA1B18F3XN4192327
CC	1.3	Transmission	CVT
Fuel Type	Gas	Type of Body	Sedan
Colour	Black

Body / Panel Condition

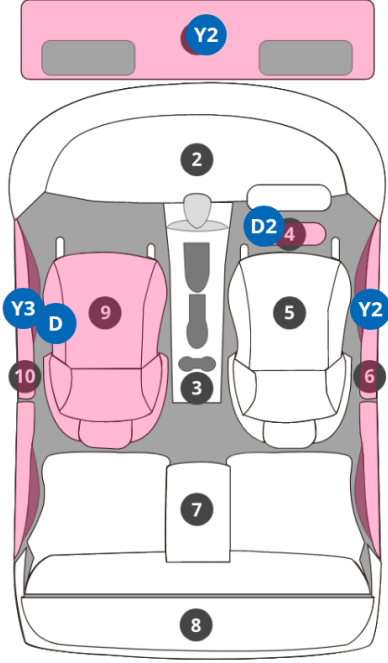
Interior Evaluation : C	Exterior Evaluation : E

<p>a : Cut, Fray d : Loose, Deformed k : Animal Hair s : Smell t : Cigarette Burns x : Defective y : Stain</p>

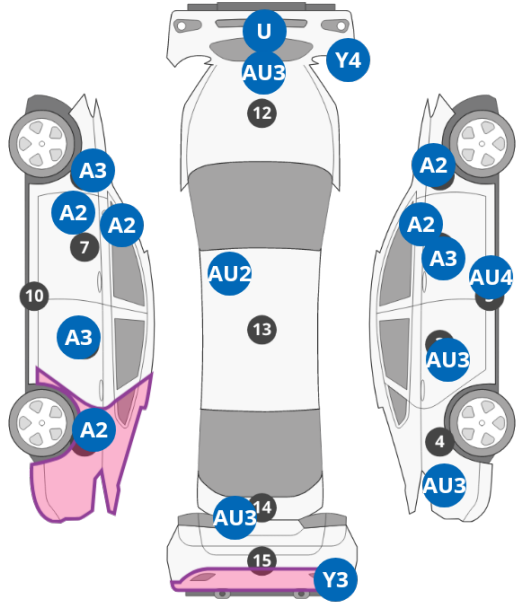
<p>A : Scratch AU : Scratch & Dent B : Modified C : Corrosion G : Stone chip P : Faded S : Rust SC : Rust & Corrosion U : Dent X : Defective Y : Crack, Gap</p>
<p>Remarks (L) Front Trim - Grime - Medium / (R) Front Trim - Grime - Small / (L) Front Seat - Worn - Yes / (L) Front Floor Mat - Worked - Small / Ceiling - Grime - Small / Overall Interior - Worn as per age - Yes</p>	<p>Remarks (R) Front Fender - Repair Traces - Yes / Rear Bumper, Lamps, Panels - Repair mark - Yes / (R) Mirror - Scratch - Small / (R) Front Fender, Molding - Scratch - Small / (R) Rear Door, Molding - Scratch & Dent - Medium / (R) Front Door, Molding - Scratch - Medium / (R) Step, In-panel, Side Spoiler - Scratch & Dent - Large / (R) Rear Fender, Molding - Scratch & Dent - Medium / Rear Bumper, Lamps, Panels - Crack, Gap - Medium / Trunk Hood, Rear Gate - Scratch & Dent - Medium / (L) Rear Fender, Molding - Repair mark - Yes / (L) Rear Fender, Molding - Scratch - Small / (L) Rear Door, Molding - Scratch - Medium / (L) Front Door, Molding - Scratch - Small / (L) Front Fender, Molding - Scratch - Medium / (L) Mirror - Scratch - Small / Member (Bolted) - Dent - Yes / Front Bumper, Grille, Lamps - Crack, Gap - Large / Bonnet, Headlight - Scratch & Dent - Medium / Roof - Scratch & Dent - Small</p>
