General Information

Make	Toyota	Model	Vios
YOM	2024	Odo Meter Reading	13,335
Registration No.	NHN8217	Chassis No.	PA1B18F31R4254607
CC	1.3	Transmission	CVT
Fuel Type	Gas	Type of Body	Sedan
Colour	Red

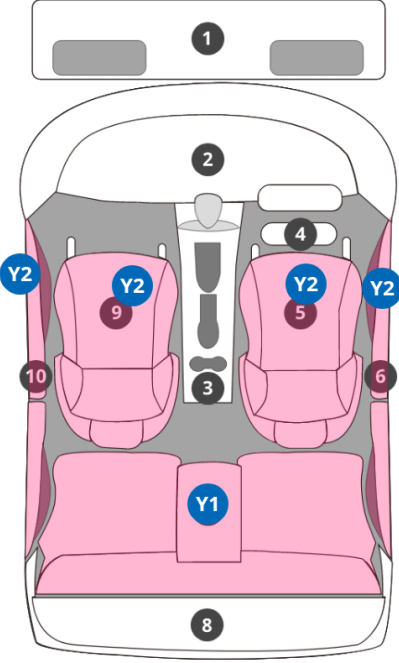
Interior Evaluation : B	Exterior Evaluation : C

<p>a : Cut, Fray d : Loose, Deformed k : Animal Hair s : Smell t : Cigarette Burns x : Defective y : Stain</p>

<p>A : Scratch AU : Scratch & Dent B : Modified C : Corrosion G : Stone chip P : Faded S : Rust SC : Rust & Corrosion U : Dent X : Defective Y : Crack, Gap</p>
<p>Remarks (R) Front Seat - Grime - Small / (R) Front Trim - Grime - Small / Rear Seat - Grime - Minimal / (L) Front Trim - Grime - Small / (L) Front Seat - Grime - Small</p>	<p>Remarks (L) Front Fender - Repair Traces - Yes / Trunk Hood, Rear Gate - Scratch - Small / Rear Bumper, Lamps, Panels - Scratch - Medium / (L) Rear Fender, Molding - Scratch - Small / (L) Rear Door, Molding - Scratch - Small / Roof - Scratch - Small / (L) Front Door, Molding - Scratch - Minimal / (L) Front Fender, Molding - Scratch - Minimal / Bonnet, Headlight - Scratch - Small / (R) Rear Fender, Molding - Scratch - Minimal / (R) Rear Door, Molding - Scratch - Small / (R) Front Fender, Molding - Scratch - Minimal / (R) Front Door, Molding - Scratch - Minimal / Front Bumper, Grille, Lamps - Scratch - Small</p>
