General Information

Make	Toyota	Model	Vios
YOM	2025	Odo Meter Reading	15,652
Registration No.	NHU5297	Chassis No.	PA1B18F31R4273934
CC	1.3	Transmission	CVT
Fuel Type	Gas	Type of Body	Sedan
Colour	Black

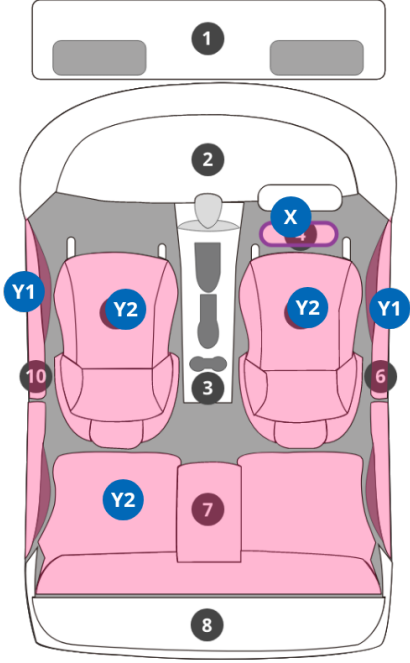
Interior Evaluation : B	Exterior Evaluation : D

<p>a : Cut, Fray d : Loose, Deformed k : Animal Hair s : Smell t : Cigarette Burns x : Defective y : Stain</p>

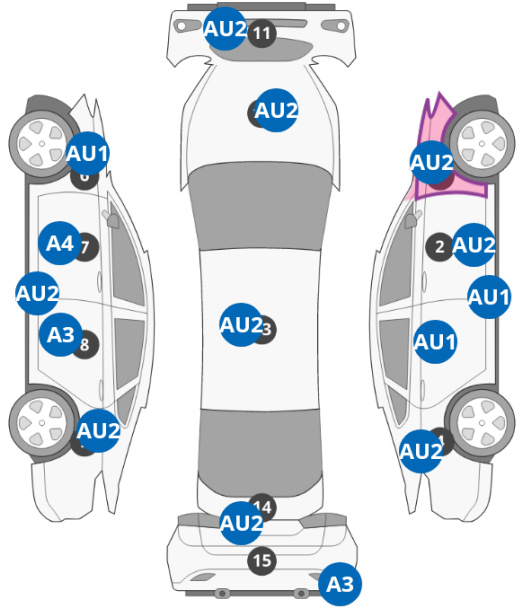
<p>A : Scratch AU : Scratch & Dent B : Modified C : Corrosion G : Stone chip P : Faded S : Rust SC : Rust & Corrosion U : Dent X : Defective Y : Crack, Gap</p>
<p>Remarks (L) Front Seat - Grime - Small / (R) Front Seat - Grime - Small / (L) Front Trim - Grime - Minimal / (R) Front Trim - Grime - Minimal / Rear Seat - Grime - Small / (L) Front Floor Mat - Missing - Yes</p>	<p>Remarks (R) Front Fender - Repair Traces - Yes / Bonnet - Repair Traces - Yes / (R) Front Fender, Molding - Repair mark - Yes / Roof - Scratch & Dent - Small / (L) Front Door, Molding - Scratch - Large / (L) Front Fender, Molding - Scratch & Dent - Minimal / (L) Step, In-panel, Side Spoiler - Scratch & Dent - Small / (L) Rear Door, Molding - Scratch - Medium / (L) Rear Fender, Molding - Scratch & Dent - Small / Rear Bumper, Lamps, Panels - Scratch - Medium / (R) Rear Fender, Molding - Scratch & Dent - Small / (R) Rear Door, Molding - Scratch & Dent - Minimal / (R) Step, In-panel, Side Spoiler - Scratch & Dent - Minimal / (R) Front Door, Molding - Scratch & Dent - Small / (R) Front Fender, Molding - Scratch & Dent - Small / Bonnet, Headlight - Scratch & Dent - Small / Front Bumper, Grille, Lamps - Scratch & Dent - Small / Trunk Hood, Rear Gate - Scratch & Dent - Small</p>
