General Information

Make	Toyota	Model	Vios
YOM	2025	Odo Meter Reading	45,412
Registration No.	NKG9014	Chassis No.	PA1B18F32R4274123
CC	1.3	Transmission	CVT
Fuel Type	Gas	Type of Body	Sedan
Colour	Red Mica Metallic

Body / Panel Condition

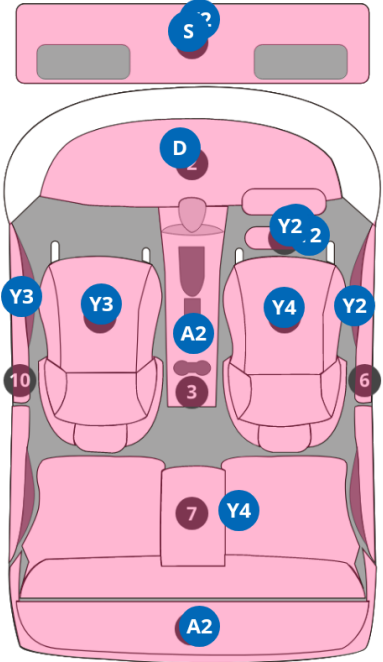
Interior Evaluation : D	Exterior Evaluation : E

<p>a : Cut, Fray d : Loose, Deformed k : Animal Hair s : Smell t : Cigarette Burns x : Defective y : Stain</p>

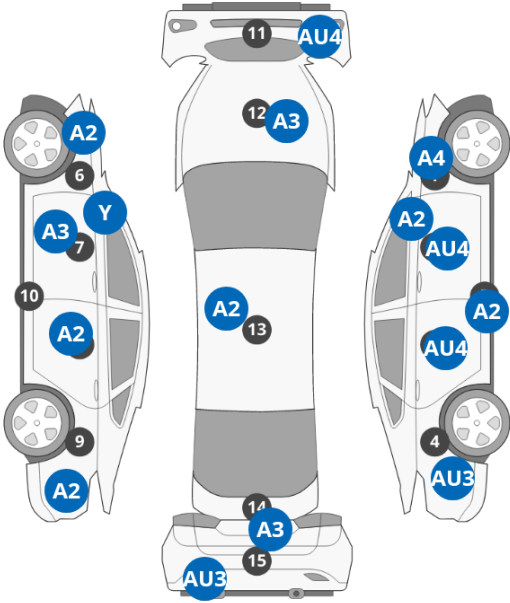
<p>A : Scratch AU : Scratch & Dent B : Modified C : Corrosion G : Stone chip P : Faded S : Rust SC : Rust & Corrosion U : Dent X : Defective Y : Crack, Gap</p>
Remarks (R) Front Seat - Grime - Large / (R) Front Trim - Grime - Small / Rear Seat - Grime - Large / Trunk Room - Worn, Scratch, Cut, Crack - Small / (L) Front Trim - Grime - Medium / (L) Front Seat - Grime - Medium / Ceiling - Grime - Small / Dashboard - Traces of Adhesive Tape - Yes / Console, Switches, Vents - Worn, Scratch, Cut, Crack - Small / Overall Interior - Smell - Yes / (L) Front Floor Mat - Grime - Small / (R) Front Floor Mat - Grime - Small / Mat Other - Grime - Small	Remarks (R) Front Fender - Repair Traces - Yes / Bonnet - Repair Traces - Yes / Roof - Scratch - Small / (L) Front Fender, Molding - Scratch - Small / Front Bumper, Grille, Lamps - Scratch & Dent - Large / (R) Front Fender, Molding - Scratch - Large / Bonnet, Headlight - Scratch - Medium / (R) Mirror - Scratch - Small / (R) Front Door, Molding - Scratch & Dent - Large / (R) Rear Door, Molding - Scratch & Dent - Large / (R) Step, In-panel, Side Spoiler - Scratch - Small / (R) Rear Fender, Molding - Scratch & Dent - Medium / Trunk Hood, Rear Gate - Scratch - Medium / Rear Bumper, Lamps, Panels - Scratch & Dent - Medium / (L) Rear Fender, Molding - Scratch - Small / (L) Rear Door, Molding - Scratch - Small / (L) Mirror - Crack - Damaged / (L) Front Door, Molding - Scratch - Medium
