General Information

Make	Toyota	Model	Innova
YOM	2024	Odo Meter Reading	19,441
Registration No.	DBJ7487	Chassis No.	PA2JA8EM2P0130822
CC	2.8	Transmission	A/T
Fuel Type	Diesel	Type of Body	Wagon
Colour	Black

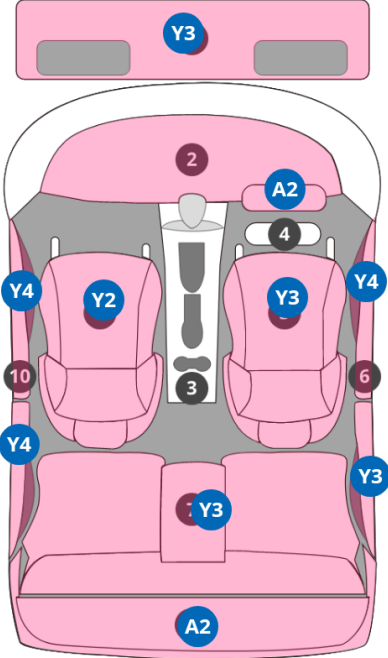
Interior Evaluation : E	Exterior Evaluation : E

<p>a : Cut, Fray d : Loose, Deformed k : Animal Hair s : Smell t : Cigarette Burns x : Defective y : Stain</p>

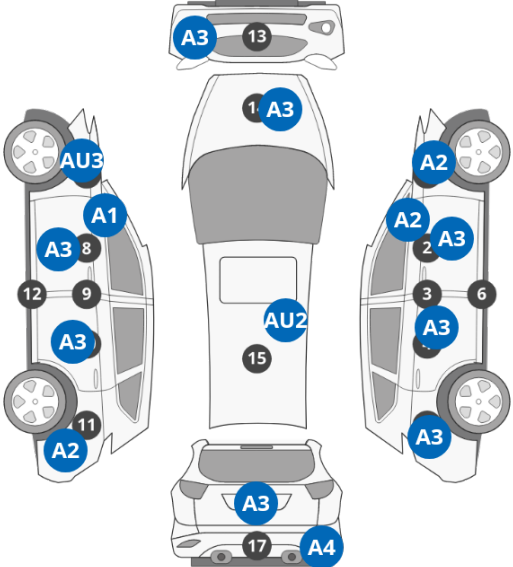
<p>A : Scratch AU : Scratch & Dent B : Modified C : Corrosion G : Stone chip P : Faded S : Rust SC : Rust & Corrosion U : Dent X : Defective Y : Crack, Gap</p>
<p>Remarks (R) Front Seat - Grime - Medium / (R) Front Trim - Grime - Large / Rear Seat - Grime - Medium / (R) Rear Trim - Grime - Medium / Trunk Room - Worn, Scratch, Cut, Crack - Small / (L) Rear Trim - Grime - Large / (L) Front Trim - Grime - Large / (L) Front Seat - Grime - Small / Steering Wheel - Worn, Peel, Crack - Small / Ceiling - Grime - Medium</p>	<p>Remarks (L) Rear Fender, Molding - Scratch - Small / Trunk Hood, Rear Gate - Scratch - Medium / Rear Bumper, Lamps, Panels - Scratch - Large / (R) Rear Fender, Molding - Scratch - Medium / (R) Rear Door, Molding - Scratch - Medium / (R) Mirror - Scratch - Small / (R) Front Door, Molding - Scratch - Medium / (R) Front Fender, Molding - Scratch - Small / Bonnet, Headlight - Scratch - Medium / Front Bumper, Grille, Lamps - Scratch - Medium / (L) Front Fender, Molding - Scratch & Dent - Medium / (L) Mirror - Scratch - Minimal / (L) Front Door, Molding - Scratch - Medium / (L) Rear Door, Molding - Scratch - Medium / Roof - Scratch & Dent - Small</p>
