General Information

Make	Toyota	Model	Vios
YOM	2024	Odo Meter Reading	28,709
Registration No.	DBM9447	Chassis No.	PA1B18F35R4242119
CC	1.3	Transmission	CVT
Fuel Type	Gas	Type of Body	Sedan
Colour	Silver

Body / Panel Condition

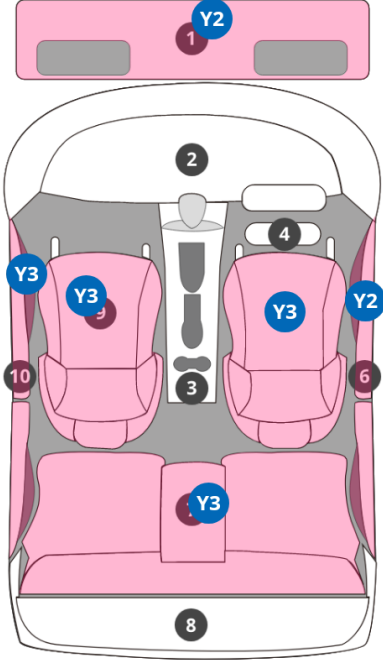
<p>a : Cut, Fray d : Loose, Deformed k : Animal Hair s : Smell t : Cigarette Burns x : Defective y : Stain</p>

<p>A : Scratch AU : Scratch & Dent B : Modified C : Corrosion G : Stone chip P : Faded S : Rust SC : Rust & Corrosion U : Dent X : Defective Y : Crack, Gap</p>
<p>Remarks (R) Front Seat - Grime - Medium / (R) Front Trim - Grime - Small / Rear Seat - Grime - Medium / (L) Front Trim - Grime - Medium / (L) Front Seat - Grime - Medium / Ceiling - Grime - Small</p>	<p>Remarks Trunk Hood, Rear Gate - Scratch - Small / (L) Rear Fender, Molding - Scratch - Minimal / (R) Step, In-panel, Side Spoiler - Scratch - Minimal / (R) Front Door, Molding - Scratch - Small / Bonnet, Headlight - Scratch - Small / Front Bumper, Grille, Lamps - Scratch - Minimal / (L) Front Door, Molding - Scratch - Small / Roof - Scratch - Small</p>
Frame Evaluation : A	Functional Evaluation : B
