General Information

Make	Toyota	Model	Vios
YOM	2024	Odo Meter Reading	17,168
Registration No.	DBM1207	Chassis No.	PA1B18F34R4240894
CC	1.3	Transmission	CVT
Fuel Type	Gas	Type of Body	Sedan
Colour	Red Mica Metallic

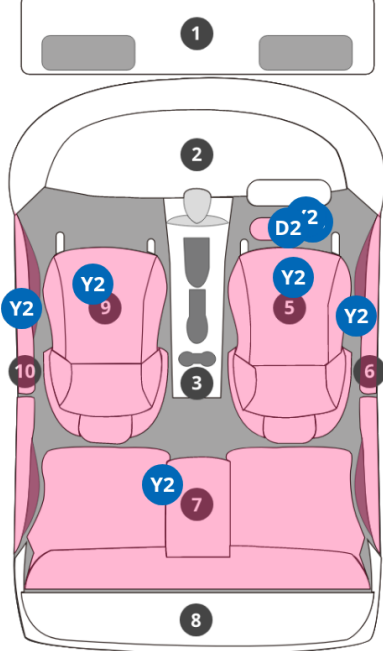
Interior Evaluation : B	Exterior Evaluation : E

<p>a : Cut, Fray d : Loose, Deformed k : Animal Hair s : Smell t : Cigarette Burns x : Defective y : Stain</p>

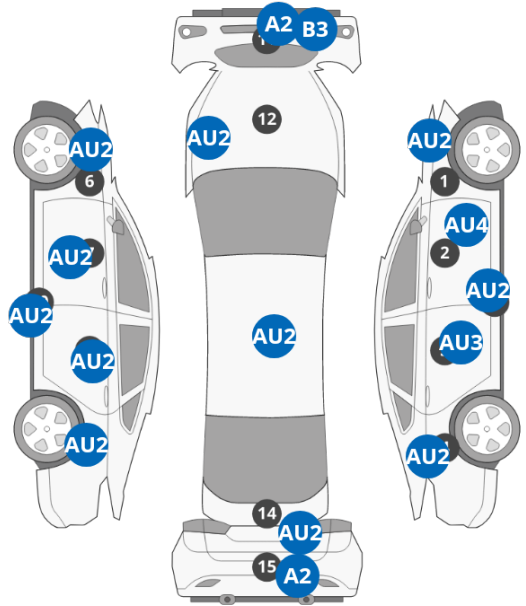
<p>A : Scratch AU : Scratch & Dent B : Modified C : Corrosion G : Stone chip P : Faded S : Rust SC : Rust & Corrosion U : Dent X : Defective Y : Crack, Gap</p>
<p>Remarks (L) Front Seat - Grime - Small / (R) Front Seat - Grime - Small / (L) Front Trim - Grime - Small / (R) Front Trim - Grime - Small / Rear Seat - Grime - Small / (L) Front Floor Mat - Cut, Crack - Medium / (R) Front Floor Mat - Grime - Small</p>	<p>Remarks (L) Rear Door, Molding - Scratch & Dent - Small / (L) Front Door, Molding - Scratch & Dent - Small / (L) Step, In-panel, Side Spoiler - Scratch & Dent - Small / Roof - Scratch & Dent - Small / (L) Rear Fender, Molding - Scratch & Dent - Small / Trunk Hood, Rear Gate - Scratch & Dent - Small / Rear Bumper, Lamps, Panels - Scratch - Small / (R) Rear Fender, Molding - Scratch & Dent - Small / (R) Rear Door, Molding - Scratch & Dent - Medium / (R) Front Door, Molding - Scratch & Dent - Large / (R) Step, In-panel, Side Spoiler - Scratch & Dent - Small / (R) Front Fender, Molding - Scratch & Dent - Small / Bonnet, Headlight - Scratch & Dent - Small / Front Bumper, Grille, Lamps - Scratch - Small / Front Bumper, Grille, Lamps - Modified - Medium / (L) Front Fender, Molding - Scratch & Dent - Small</p>

<p>Inspector Notes</p>
<p>with LTO plate, with jack, with reverse camera, with spare tire scratches on taillight and headlight, no tools, no spare key.</p>
