General Information

Make	Toyota	Model	Lite Ace
YOM	2024	Odo Meter Reading	20,132
Registration No.	DBO3645	Chassis No.	MHKU3FE10PK005800
CC	1.5	Transmission	M/T
Fuel Type	Gas	Type of Body	Utility Passenger
Colour	White

Body / Panel Condition

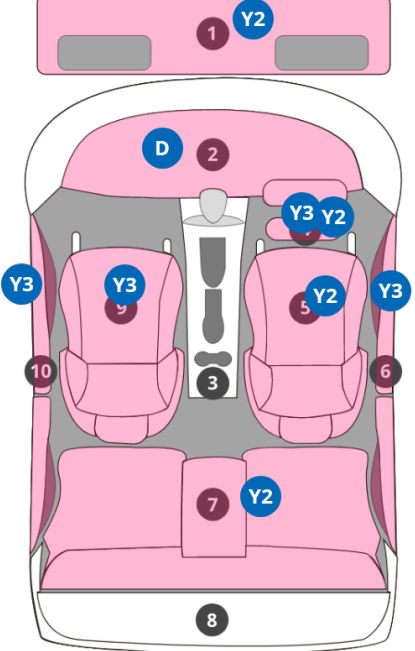
Interior Evaluation : C	Exterior Evaluation : D

<p>a : Cut, Fray d : Loose, Deformed k : Animal Hair s : Smell t : Cigarette Burns x : Defective y : Stain</p>

<p>A : Scratch AU : Scratch & Dent B : Modified C : Corrosion G : Stone chip P : Faded S : Rust SC : Rust & Corrosion U : Dent X : Defective Y : Crack, Gap</p>
<p>Remarks (L) Front Seat - Grime - Medium / (R) Front Seat - Grime - Small / (L) Front Floor Mat - Grime - Medium / (R) Front Floor Mat - Grime - Small / (L) Front Trim - Grime - Medium / (R) Front Trim - Grime - Medium / Rear Seat - Grime - Small / Dashboard - Traces of Adhesive Tape - Yes / Ceiling - Grime - Small</p>	<p>Remarks Cargo Bed Floor - Scratch & Dent - Medium / (L) Center Panel - Scratch & Dent - Minimal / (L) Front Door, Molding - Scratch & Dent - Small / Roof - Scratch & Dent - Small / (L) Front Fender, Molding - Scratch & Dent - Small / Front Panel - Scratch & Dent - Small / (R) Front Fender, Molding - Scratch & Dent - Small / (R) Front Door, Molding - Scratch & Dent - Small / (R) Center Panel - Scratch & Dent - Small / (R) Rear Door, Molding - Scratch & Dent - Minimal / (R) Step, In-panel, Side Spoiler - Scratch & Dent - Minimal / Rear Gate - Scratch & Dent - Medium / (R) Side Gate - Scratch & Dent - Medium / Rear Bumper, Lamps, Panels - Scratch & Dent - Small / (L) Side Gate - Scratch & Dent - Small / (L) Rear Door, Molding - Scratch & Dent - Small / (L) Step, In-panel, Side Spoiler - Scratch & Dent - Minimal / Front Bumper, Grille, Lamps - Scratch - Small</p>

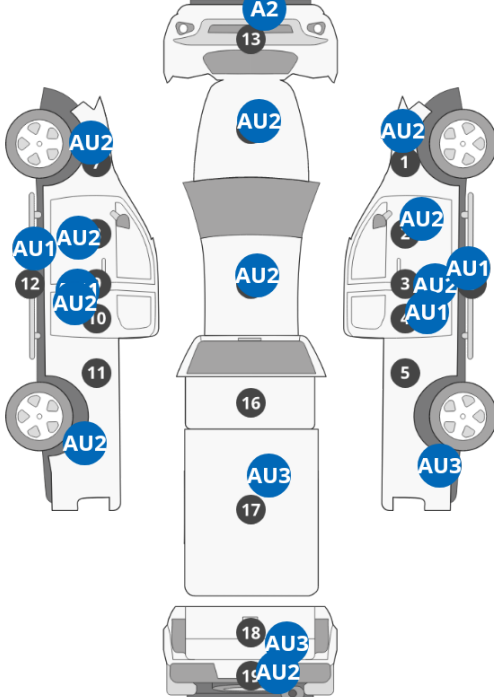
<p>Inspector Notes</p>
<p>with LTO plate, with spare tire, with manual booklet, no spare key, no tools, no jack, scratches on taillight and headlight,</p>
