General Information

Make	Toyota	Model	Vios
YOM	2024	Odo Meter Reading	5,363
Registration No.	DBO5450	Chassis No.	PA1B18F3XR4238972
CC	1.3	Transmission	CVT
Fuel Type	Gas	Type of Body	Sedan
Colour	Blue

Body / Panel Condition

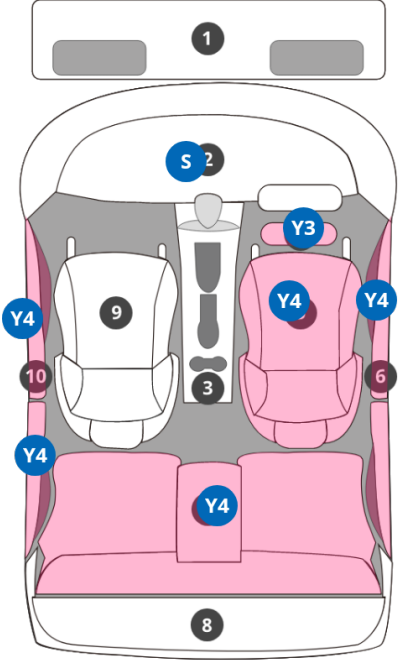
Interior Evaluation : D	Exterior Evaluation : C

<p>a : Cut, Fray d : Loose, Deformed k : Animal Hair s : Smell t : Cigarette Burns x : Defective y : Stain</p>

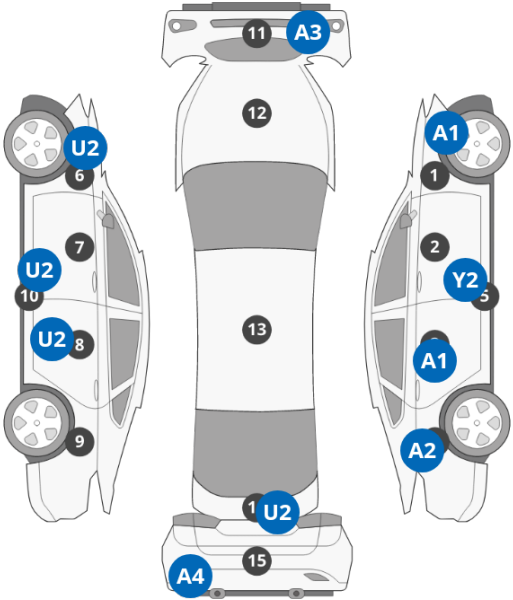
<p>A : Scratch AU : Scratch & Dent B : Modified C : Corrosion G : Stone chip P : Faded S : Rust SC : Rust & Corrosion U : Dent X : Defective Y : Crack, Gap</p>
<p>Remarks Rear Seat - Grime - Large / Overall Interior - Smell - Yes / (R) Front Seat - Grime - Large / (R) Front Trim - Grime - Large / (R) Front Floor Mat - Grime - Medium / (L) Rear Trim - Grime - Large / (L) Front Trim - Grime - Large</p>	<p>Remarks Rear Bumper, Lamps, Panels - Scratch - Large / Trunk Hood, Rear Gate - Dent - Small / (L) Front Fender, Molding - Dent - Small / (L) Front Door, Molding - Dent - Small / (L) Rear Door, Molding - Dent - Small / (R) Front Door, Molding - Crack, Gap - Small / Front Bumper, Grille, Lamps - Scratch - Medium / (R) Rear Fender, Molding - Scratch - Small / (R) Rear Door, Molding - Scratch - Minimal / (R) Front Fender, Molding - Scratch - Minimal</p>
