## General Information

| <b>Make</b> | Toyota | <b>Model</b> | Vios |

## Body / Panel Condition

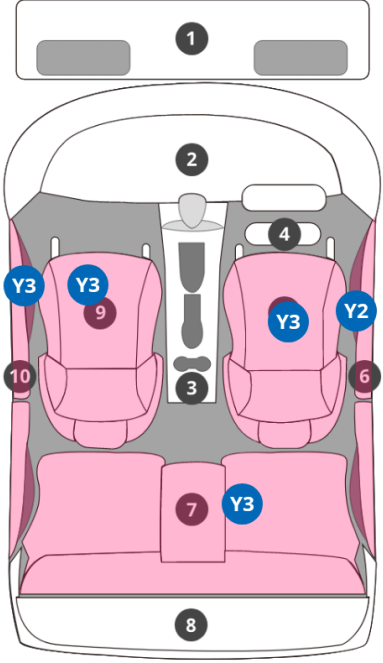
| <b>Interior Evaluation :</b> <span style="float: right;"><b>B</b></span> | <b>Exterior Evaluation :</b> <span style="float: right;"><b>D</b></span> |
| <p><b>Remarks</b><br/>(R) Front Seat - Grime - Medium / (R) Front Trim - Grime - Small / Rear Seat - Grime - Medium / (L) Front Trim - Grime - Medium / (L) Front Seat - Grime - Medium</p> | <p><b>Remarks</b><br/>Trunk Hood, Rear Gate - Scratch - Small / Rear Bumper, Lamps, Panels - Scratch - Small / (R) Rear Fender, Molding - Scratch - Medium / (R) Rear Door, Molding - Scratch - Small / (R) Front Fender, Molding - Scratch - Minimal / Bonnet, Headlight - Scratch - Small / Front Bumper, Grille, Lamps - Scratch &amp; Dent - Large / (L) Front Fender, Molding - Scratch - Minimal / (L) Front Door, Molding - Scratch - Small / (L) Rear Door, Molding - Scratch &amp; Dent - Medium / (L) Rear Fender, Molding - Scratch - Medium / Roof - Scratch - Small</p> |
