General Information

Make	Toyota	Model	Wigo
YOM	2025	Odo Meter Reading	18,806
Registration No.	DBS3678	Chassis No.	MHKAA1BC4RJ028086
CC	1.0	Transmission	CVT
Fuel Type	Gas	Type of Body	Hatchback
Colour	Gray

Body / Panel Condition

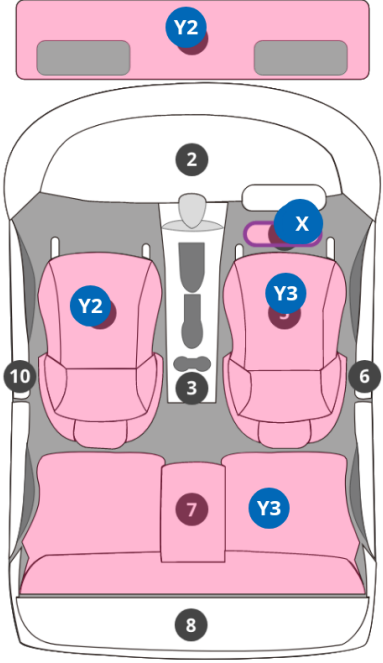
Interior Evaluation : B	Exterior Evaluation : C

<p>a : Cut, Fray d : Loose, Deformed k : Animal Hair s : Smell t : Cigarette Burns x : Defective y : Stain</p>

<p>A : Scratch AU : Scratch & Dent B : Modified C : Corrosion G : Stone chip P : Faded S : Rust SC : Rust & Corrosion U : Dent X : Defective Y : Crack, Gap</p>
<p>Remarks (R) Front Seat - Grime - Medium / (R) Front Floor Mat - Missing - Yes / Rear Seat - Grime - Medium / Mat Other - Missing - Yes / (L) Front Seat - Grime - Small / (L) Front Floor Mat - Missing - Yes / Ceiling - Grime - Small</p>	<p>Remarks (L) Mirror - Scratch - Minimal / (L) Front Door, Molding - Scratch - Small / (L) Front Fender, Molding - Scratch - Minimal / (L) Rear Door, Molding - Scratch - Small / (L) Rear Fender, Molding - Scratch & Dent - Small / Trunk Hood, Rear Gate - Scratch - Small / Rear Bumper, Lamps, Panels - Scratch - Small / (R) Rear Fender, Molding - Scratch - Minimal / (R) Rear Door, Molding - Scratch - Small / (R) Front Door, Molding - Scratch & Dent - Medium / (R) Step, In-panel, Side Spoiler - Scratch - Minimal / (R) Front Fender, Molding - Scratch - Minimal / Bonnet, Headlight - Scratch - Minimal / Front Bumper, Grille, Lamps - Scratch & Dent - Medium / Roof - Scratch & Dent - Small</p>
