General Information

Make	Toyota	Model	Vios
YOM	2025	Odo Meter Reading	9,145
Registration No.	DBS4919	Chassis No.	PA1B18F30R4278252
CC	1.3	Transmission	CVT
Fuel Type	Gas	Type of Body	Sedan
Colour	Red

Body / Panel Condition

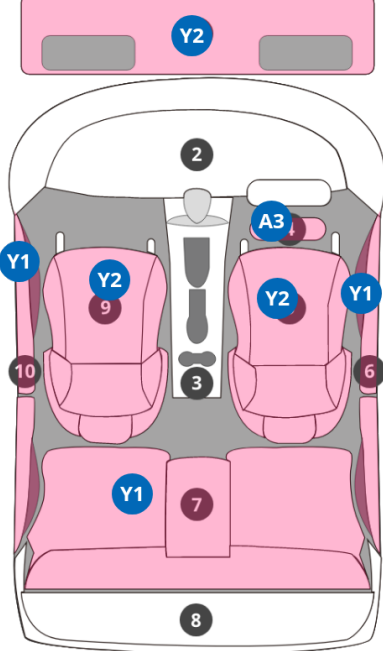
Interior Evaluation : B	Exterior Evaluation : C

<p>a : Cut, Fray d : Loose, Deformed k : Animal Hair s : Smell t : Cigarette Burns x : Defective y : Stain</p>

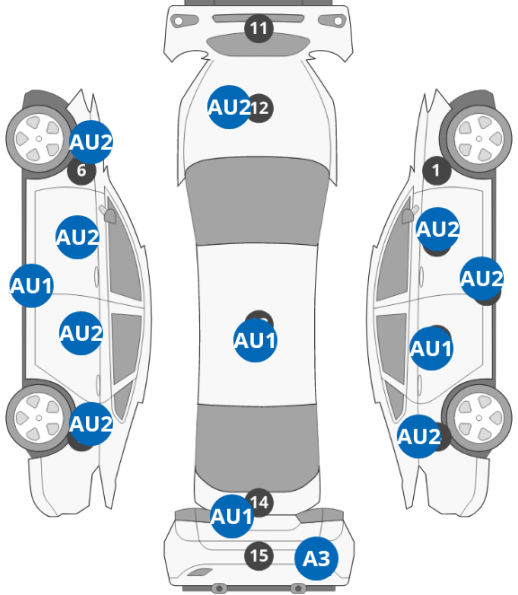
<p>A : Scratch AU : Scratch & Dent B : Modified C : Corrosion G : Stone chip P : Faded S : Rust SC : Rust & Corrosion U : Dent X : Defective Y : Crack, Gap</p>
<p>Remarks (L) Front Floor Mat - Cut, Crack - Medium / (L) Front Seat - Grime - Small / (R) Front Seat - Grime - Small / (L) Front Trim - Grime - Minimal / (R) Front Trim - Grime - Minimal / Rear Seat - Grime - Minimal / Ceiling - Grime - Small</p>	<p>Remarks Bonnet, Headlight - Scratch & Dent - Small / (L) Front Fender, Molding - Scratch & Dent - Small / (L) Front Door, Molding - Scratch & Dent - Small / (L) Rear Door, Molding - Scratch & Dent - Small / (L) Step, In-panel, Side Spoiler - Scratch & Dent - Minimal / (L) Rear Fender, Molding - Scratch & Dent - Small / Trunk Hood, Rear Gate - Scratch & Dent - Minimal / Rear Bumper, Lamps, Panels - Scratch - Medium / (R) Rear Fender, Molding - Scratch & Dent - Small / (R) Rear Door, Molding - Scratch & Dent - Minimal / (R) Front Door, Molding - Scratch & Dent - Small / (R) Step, In-panel, Side Spoiler - Scratch & Dent - Small / Roof - Scratch & Dent - Minimal</p>
