General Information

Make	Toyota	Model	Vios
YOM	2025	Odo Meter Reading	5,960
Registration No.	DBT7390	Chassis No.	PA1B18F31S4285698
CC	1.3	Transmission	CVT
Fuel Type	Gas	Type of Body	Sedan
Colour	Red

Body / Panel Condition

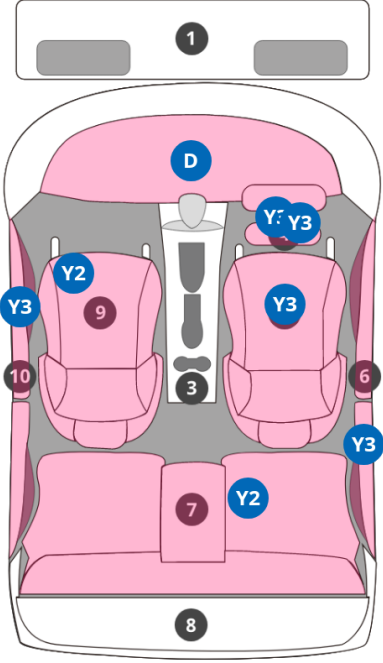
Interior Evaluation : C	Exterior Evaluation : D

<p>a : Cut, Fray d : Loose, Deformed k : Animal Hair s : Smell t : Cigarette Burns x : Defective y : Stain</p>

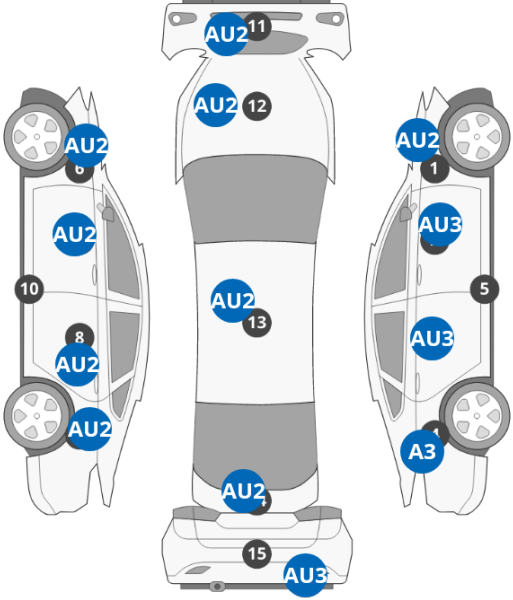
<p>A : Scratch AU : Scratch & Dent B : Modified C : Corrosion G : Stone chip P : Faded S : Rust SC : Rust & Corrosion U : Dent X : Defective Y : Crack, Gap</p>
<p>Remarks (R) Front Seat - Grime - Medium / (L) Front Floor Mat - Grime - Medium / (R) Front Floor Mat - Grime - Medium / (L) Front Trim - Grime - Medium / (R) Rear Trim - Grime - Medium / Dashboard - Traces of Adhesive Tape - Yes / Rear Seat - Grime - Small / (L) Front Seat - Grime - Small</p>	<p>Remarks Bonnet, Headlight - Scratch & Dent - Small / Front Bumper, Grille, Lamps - Scratch & Dent - Small / (L) Front Door, Molding - Scratch & Dent - Small / (L) Rear Door, Molding - Scratch & Dent - Small / Roof - Scratch & Dent - Small / (R) Front Fender, Molding - Scratch & Dent - Small / (R) Rear Fender, Molding - Scratch - Medium / Rear Bumper, Lamps, Panels - Scratch & Dent - Medium / Trunk Hood, Rear Gate - Scratch & Dent - Small / (L) Rear Fender, Molding - Scratch & Dent - Small / (R) Rear Door, Molding - Scratch & Dent - Medium / (R) Front Door, Molding - Scratch & Dent - Medium / (L) Front Fender, Molding - Scratch & Dent - Small</p>
