## General Information

<b>Make</b>	Toyota	<b>Model</b>	Vios
<b>YOM</b>	2025	<b>Odo Meter Reading</b>	19,118
<b>Registration No.</b>	FAT1911	<b>Chassis No.</b>	PA1B18F34S4284691
<b>CC</b>	1.3	<b>Transmission</b>	CVT
<b>Fuel Type</b>	Gas	<b>Type of Body</b>	Sedan
<b>Colour</b>	Silver

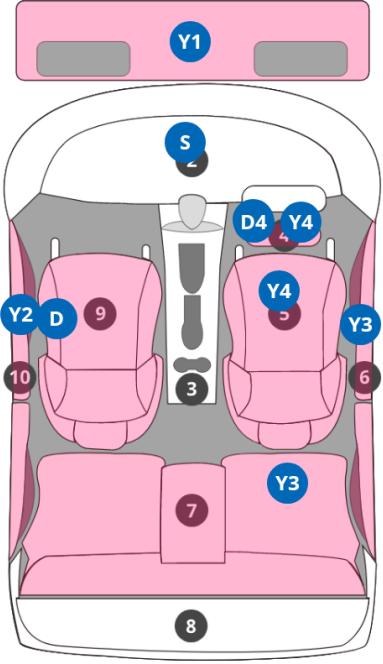
<b>Interior Evaluation :</b> <span style="float: right; color: red; font-weight: bold;">D</span>	<b>Exterior Evaluation :</b> <span style="float: right; color: red; font-weight: bold;">E</span>

<p><b>A</b> : Scratch <b>AU</b> : Scratch &amp; Dent <b>B</b> : Modified <b>C</b> : Corrosion <b>G</b> : Stone chip <b>P</b> : Faded <b>S</b> : Rust <b>SC</b> : Rust &amp; Corrosion <b>U</b> : Dent <b>X</b> : Defective <b>Y</b> : Crack, Gap</p>
<p><b>Remarks</b> (R) Front Seat - Grime - Large / (L) Front Floor Mat - Cut, Crack - Medium / (L) Front Floor Mat - Worked - Large / (L) Front Seat - Worn - Yes / (R) Front Floor Mat - Grime - Large / (R) Front Trim - Grime - Medium / (L) Front Trim - Grime - Small / Rear Seat - Grime - Medium / Overall Interior - Smell - Yes / Ceiling - Grime - Minimal</p>	<p><b>Remarks</b> (R) Front Door, Molding - Scratch - Medium / (R) Front Fender, Molding - Scratch - Small / (R) Mirror - Scratch - Small / (R) Step, In-panel, Side Spoiler - Scratch &amp; Dent - Medium / (R) Rear Door, Molding - Scratch - Medium / (R) Rear Fender, Molding - Scratch - Small / Rear Bumper, Lamps, Panels - Scratch - Small / Trunk Hood, Rear Gate - Scratch - Small / (L) Rear Fender, Molding - Scratch - Small / (L) Rear Door, Molding - Scratch - Large / (L) Front Door, Molding - Scratch - Large / (L) Mirror - Scratch - Small / (L) Front Fender, Molding - Scratch &amp; Dent - Small / Front Bumper, Grille, Lamps - Scratch &amp; Dent - Small / Bonnet, Headlight - Scratch - Small / Roof - Scratch - Medium</p>

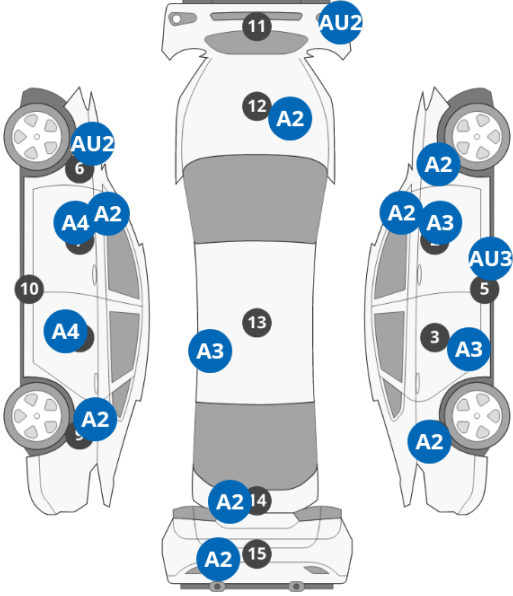
<p><b>Inspector Notes</b></p>
<p>no warranty booklet, with jack, incomplete tools, with spare tire and LTO PLATE, scratches on tail light, left side mirror issue</p>
